Report on Emergency Felling of Stonewall Trees on Slope No. 11SW-A/R577 at Bonham Road / St Stephen's Lane on 7 August 2015

Highways Department
August 2015

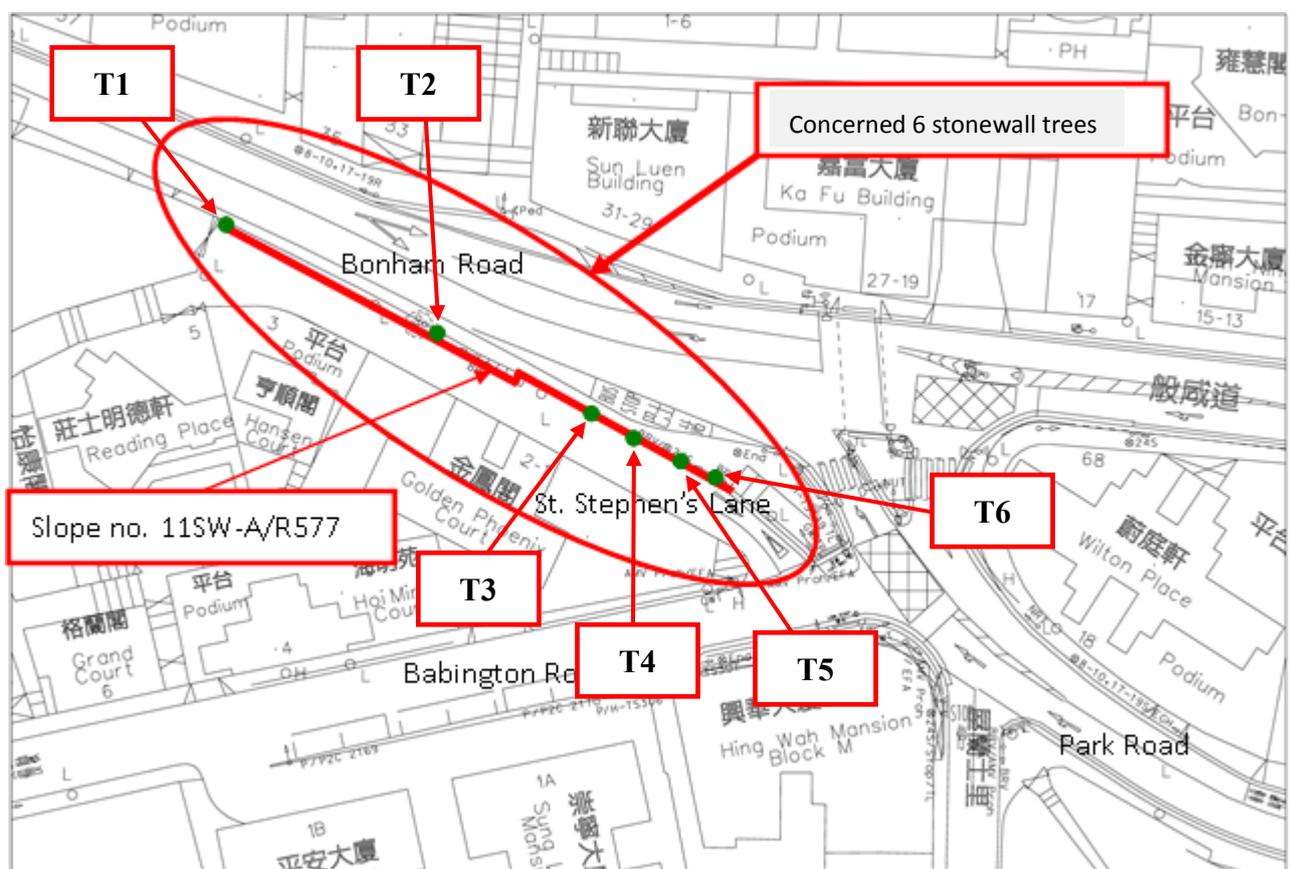
1.1 At slope no. 11SW-A/R577 between Bonham Road and St. Stephen's Lane, there were six stonewall trees (trees T1 to T6) growing on it (Figure 1.1). All the trees and the stonewall were maintained by Highways Department (HyD).

Figure 1.1: Location of the concerned stonewall trees

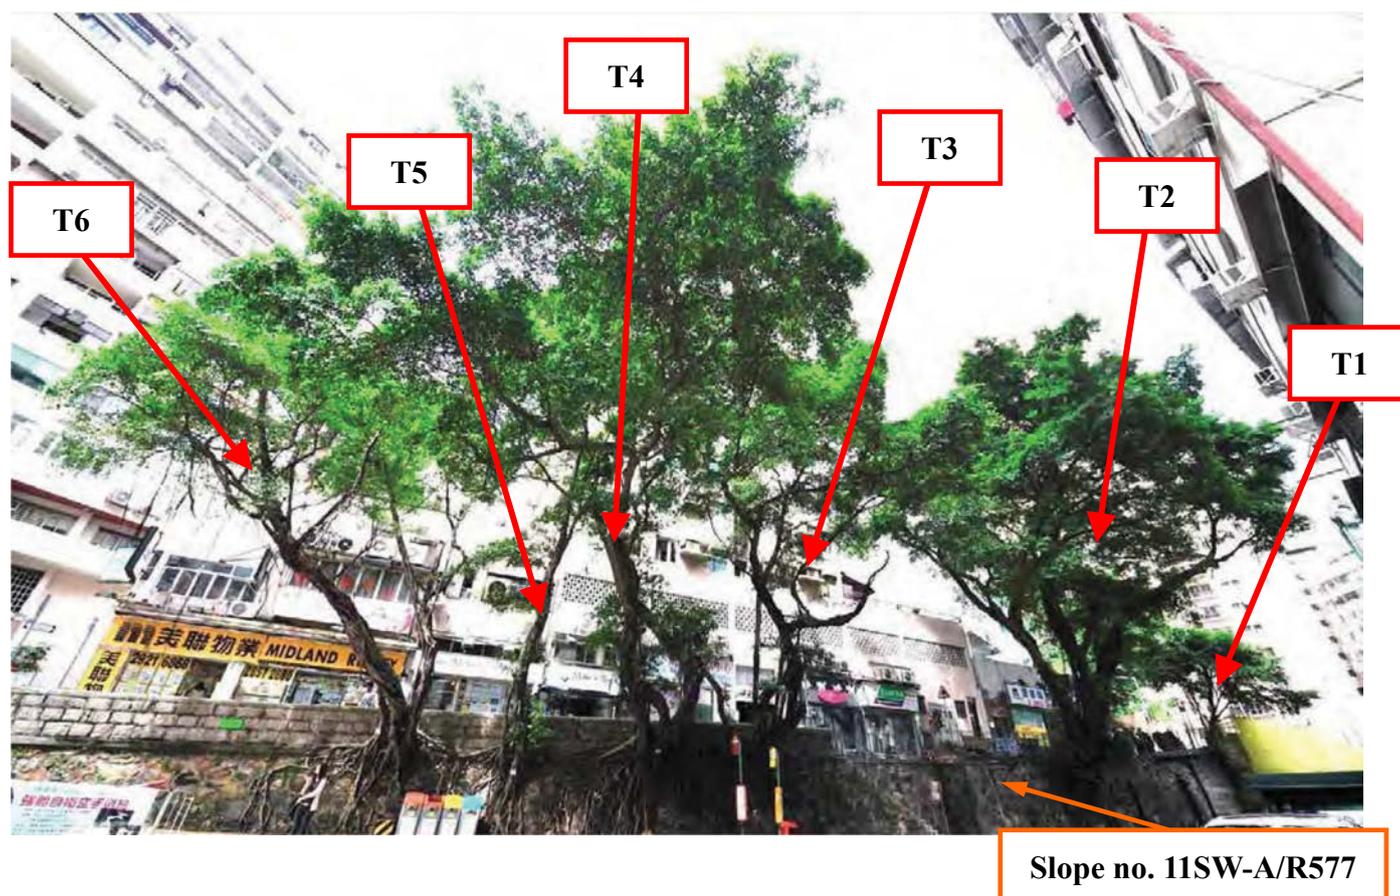
1.3 In 2013, some signs of risks of root detachment and trunk cavity at trees T4 and T5 respectively were observed. HyD had invited an external tree expert to carry out a study to identify the factors affecting the health and stability of the stonewall trees, formulate suitable maintenance measures for their sustainable growth and advise on mitigation measures to minimize the risk of tree failure (the 2013 Study). The overall view of the trees is shown on Photo 1.1.

Photo 1.1 – Overall view of the 6 stonewall trees

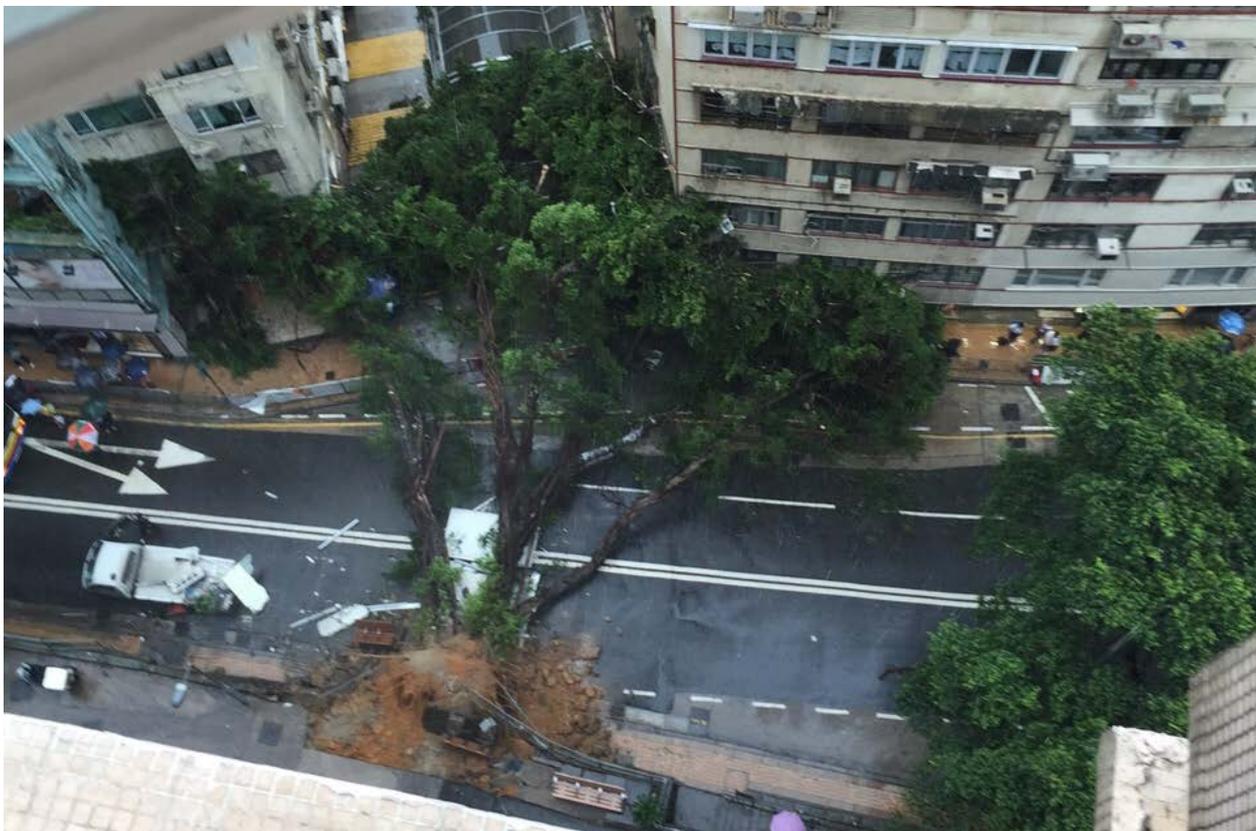
- 2.1 On 22 July 2015 at around 12:00 noon, tree T2 collapsed suddenly. Bonham Road was blocked totally by the collapsed tree in a toppling manner. Moreover, a male newspaper vendor and a female pedestrian were injured. A truck passing by was hit and damaged. The buildings facing the collapsed tree at the opposite side of Bonham Road and the escalator cover at Centre Street were damaged.

Photo 2.1 – Tree T2 collapsed on 22 July 2015

- 3.3 For the collapsed tree T2, it was grew on and supported mostly by the upper part of the stonewall body. The tree trunk did not show any symptom of decay. Moreover, part of the stonewall collapsed together with the stonewall tree. The damage to the stonewall was nevertheless localized around the root of the tree, while the other portion of the stonewall appeared to be intact and did not exhibit any sign

of distress. From the caved-in left behind by the collapsed tree, root intrusion to the stonewall core was observed. It was considered that the tree collapse was due to the failure of the tree anchorage at the upper part of the stonewall body (i.e. failure mode C as described in paragraph 3.2) as a result of the dead weight of the tree and the external loadings at the time of collapse, like wind and rain water intercepted/absorbed by the tree. There was no sign that the collapse was caused by any instability of the stonewall itself.

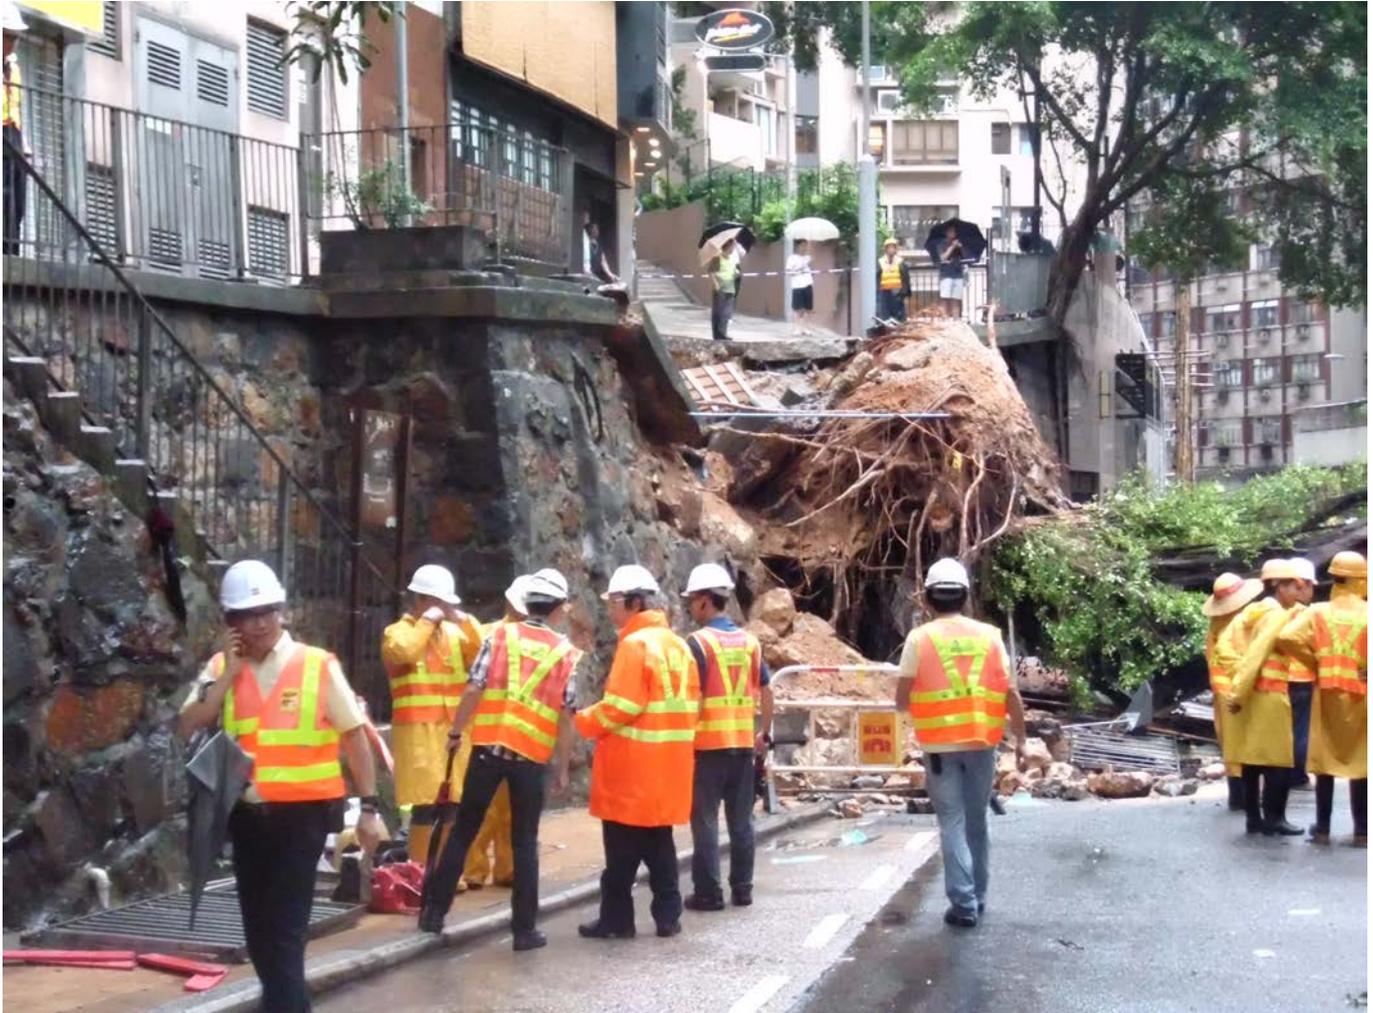
2.2 During the incident, the stonewall was also damaged. GEO confirmed that it was not a landslide incident. The caved-in portion was localized around the root of the tree. The other portion of the stonewall appeared to be intact and did not exhibit any sign of distress.

Photo 2.2 – Stonewall Damaged together with Tree T2

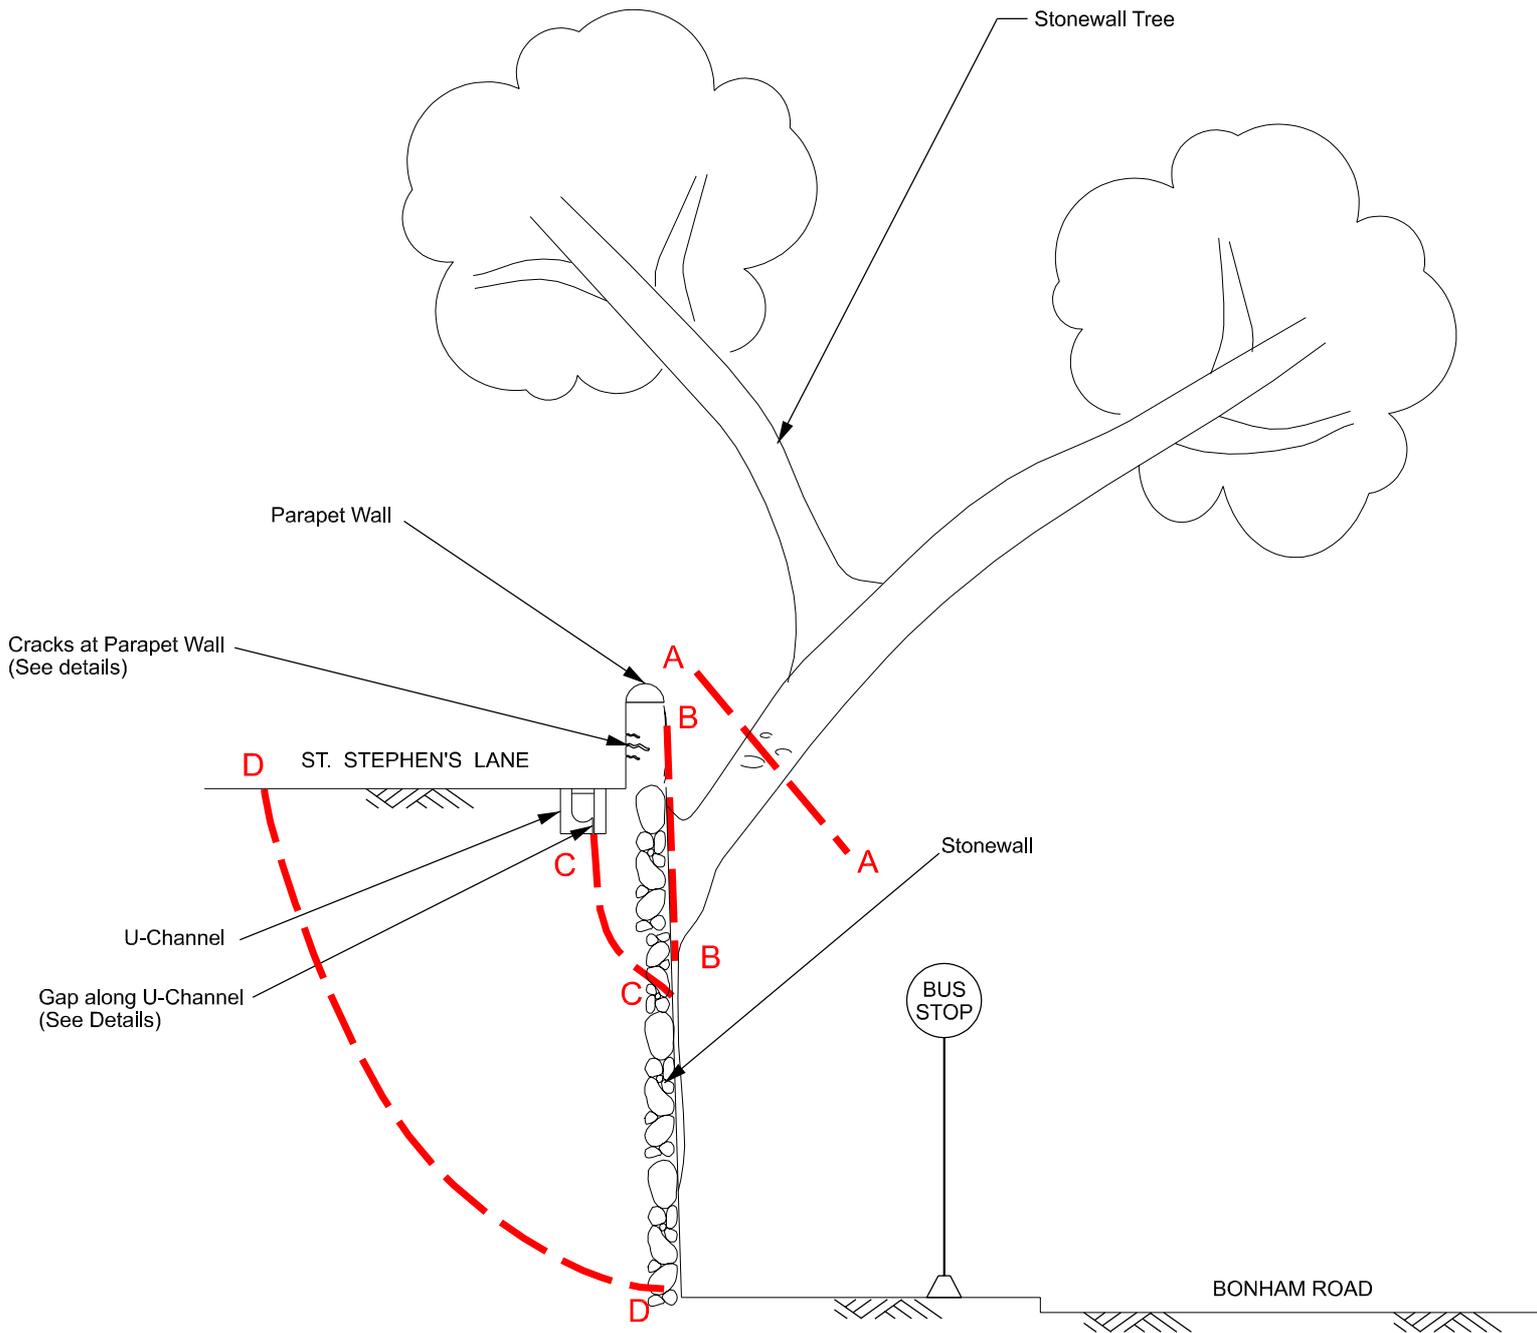
Diagram1

- 3.1 After the tree T2 collapse accident, HyD reviewed the possible cause of tree collapse.
- 3.2 Generally speaking, there were four possible failure modes for stonewall trees (see **Diagram 1**) as follows –

Possible Failure Modes :

- A Tree trunk failure
- B Tree root detachment from stonewall
- C Tree anchorage shallow failure
- D Overall failure

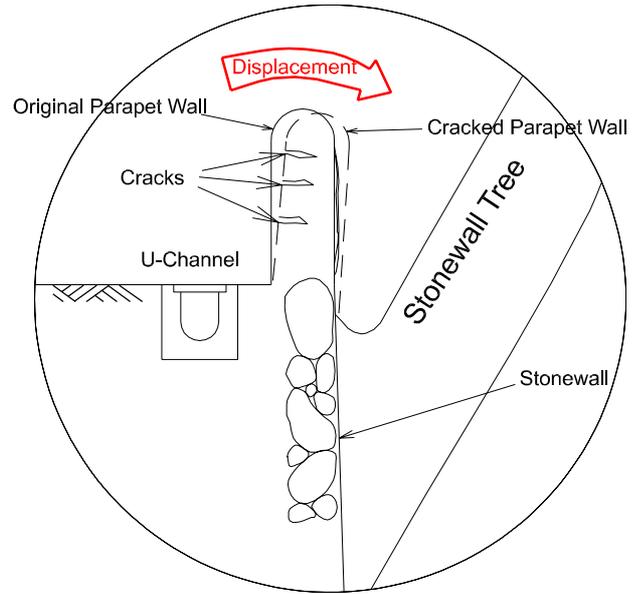
- 4.5 On 5 August 2015, 11 new cracks were found at the parapet wall behind T4, T5 and T6 (Refer to **Diagram 2**). The cracks were not noticed during the inspection of 3 August 2015. HyD immediately stepped up monitoring the situation.

- 5.2 It was considered that the cracks found at different parts of the parapet wall were caused by lateral forces exerted on the wall and displacements of the parapet walls had occurred. These cracks also indicated that the integrity of the part of the tree anchorage connected to the parapet wall had already been hampered and its contribution to the resistance to the toppling of trees T4, T5 and T6 had also been weakened.

Cracks at Parapet Wall

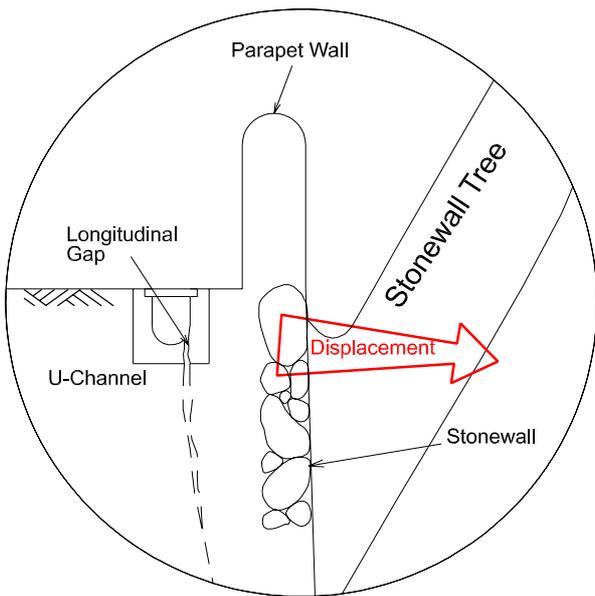
- 5.3 Further, the longitudinal gaps throughout the length of the U-channel at the crest of the stonewall was also considered to be another alarming sign of displacement which had occurred at the tree anchorages located at the upper portion of the stonewall.

Longitudinal Gap at U-Channel

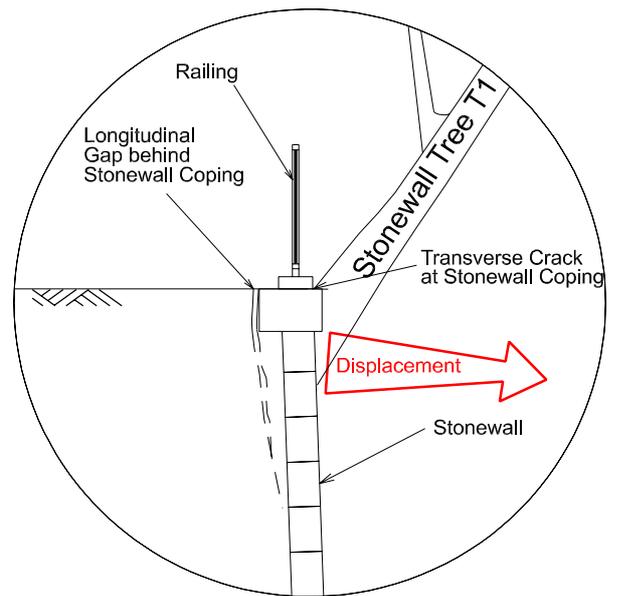
The gap indicated that displacement had occurred at the base of the parapet wall and the crest of the stonewall. Such sign of instability, together with the parapet wall cracks, occurring at the top part (tension part) of the tree anchorage, could have detrimental effect on the resistance to tree toppling. Besides, such gap of persistent length might penetrate to a depth along a significant stretch of the stonewall crest. It could induce a tree anchorage shallow failure (similar to that of the collapsed tree T2) to any of trees T4, T5 and T6. The combination of the cracks at the parapet wall and the gap at the U-channel increased the likelihood that the root anchorage of the trees was being compromised, which in turn increased the likelihood of their destabilization. They might fall together with parts of the stonewall crest (as evidence in the collapsed tree T2) and a significant stretch of the parapet wall.

Longitudinal Gap behind Stonewall

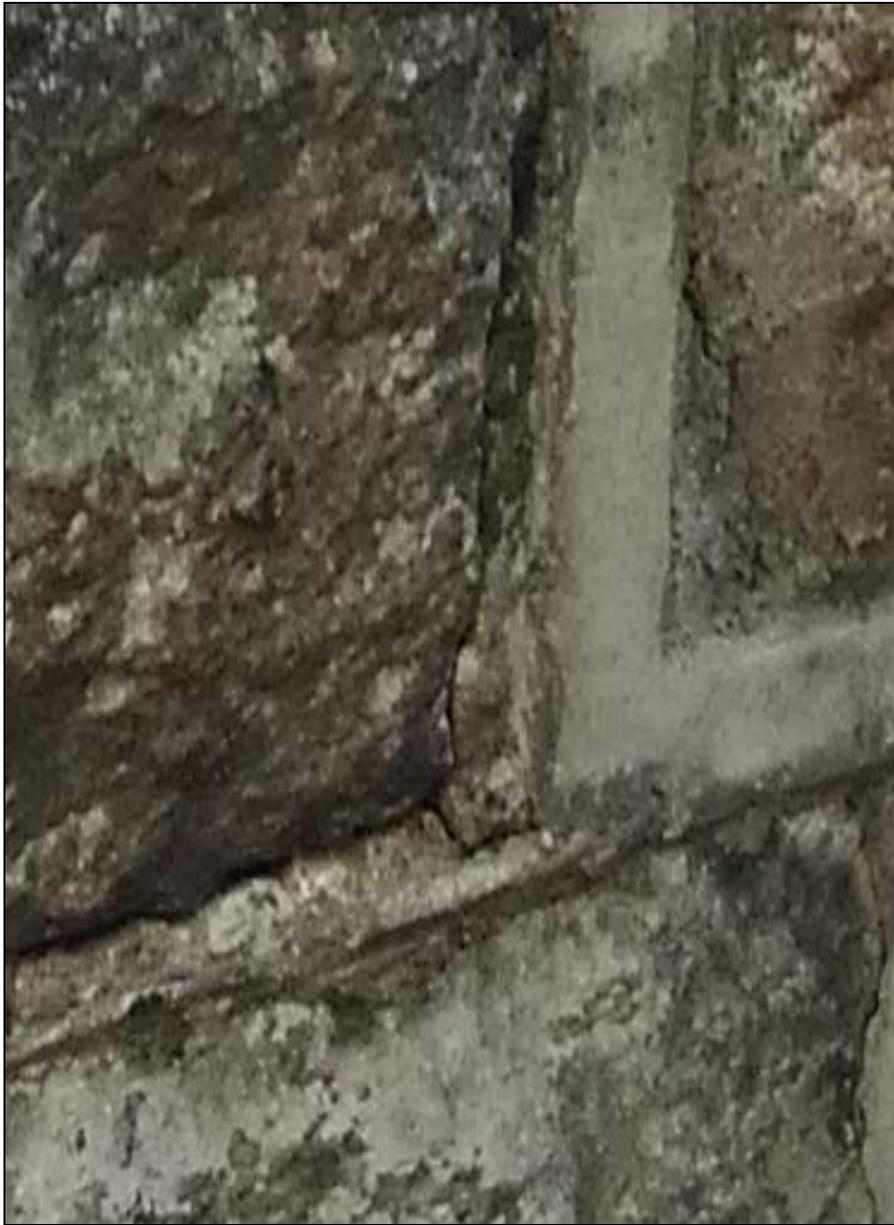
Crack P.11 (2015-08-05)

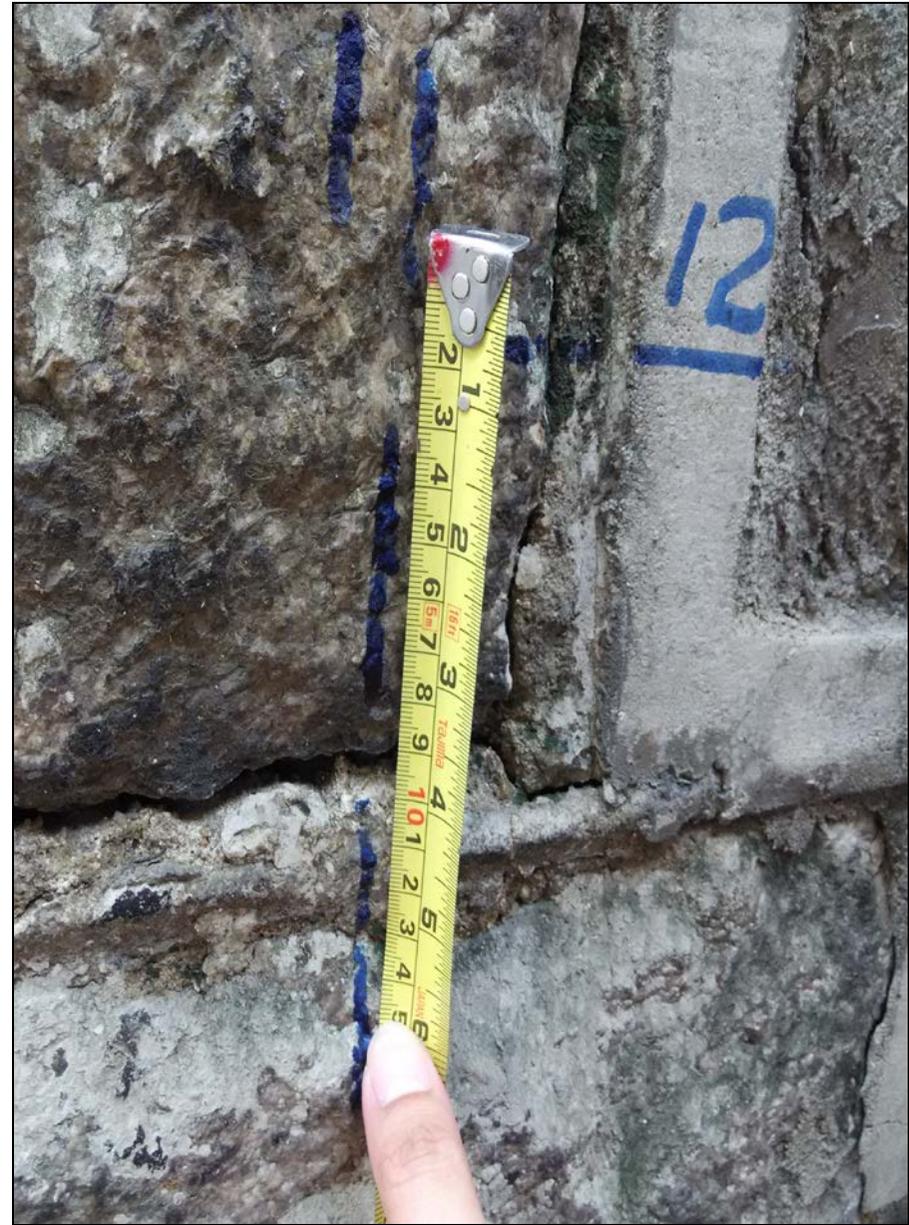
Crack P.11 (2015-08-06)

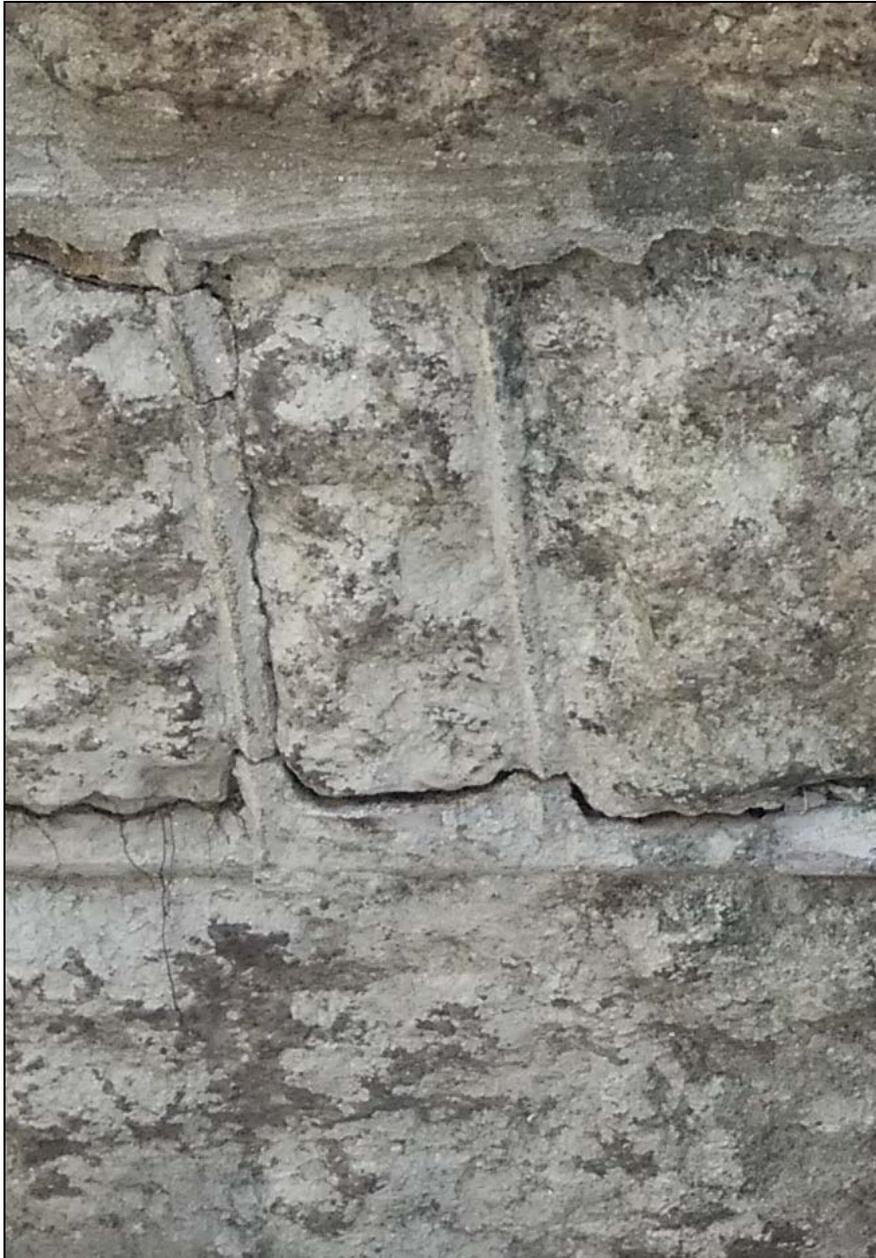
Crack P.5 (2015-08-05)

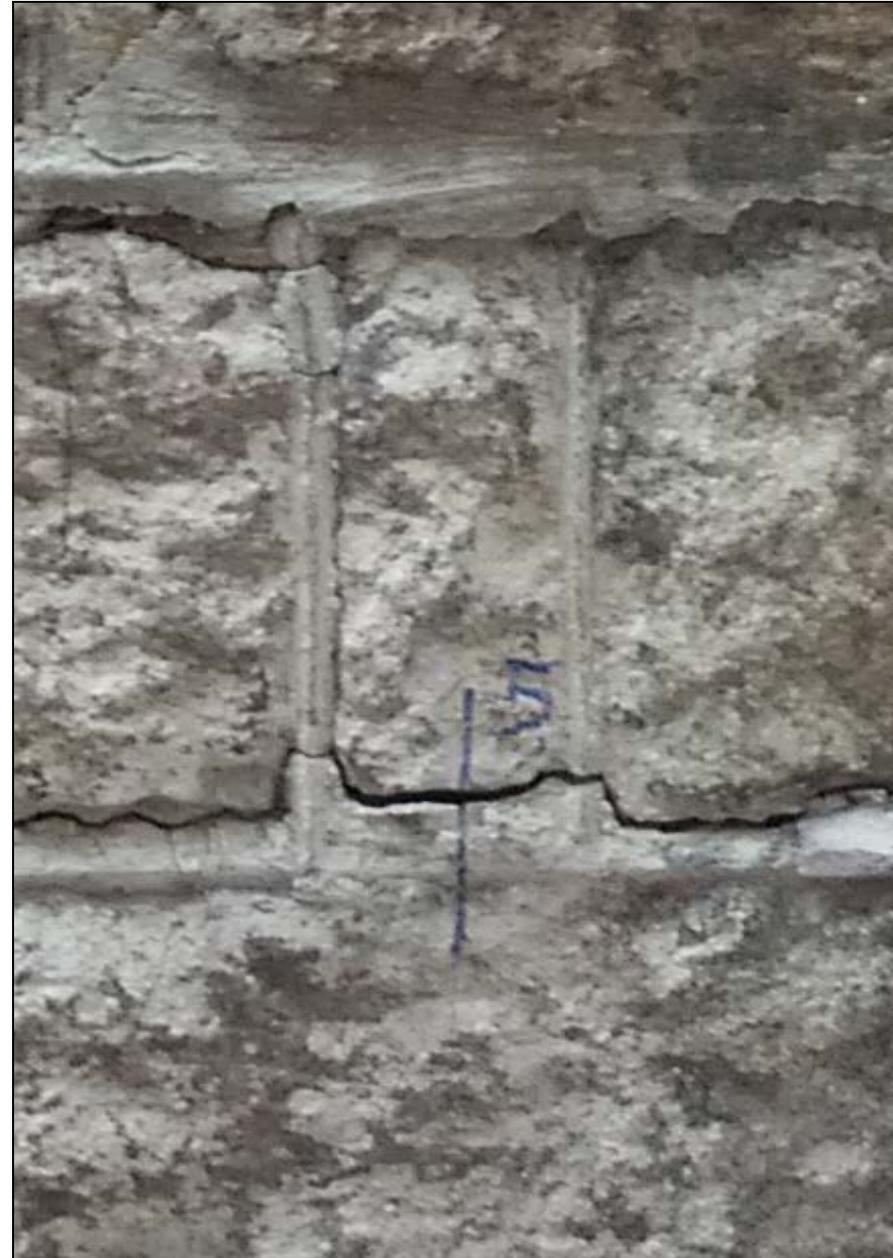
Crack P.5 (2015-08-06)

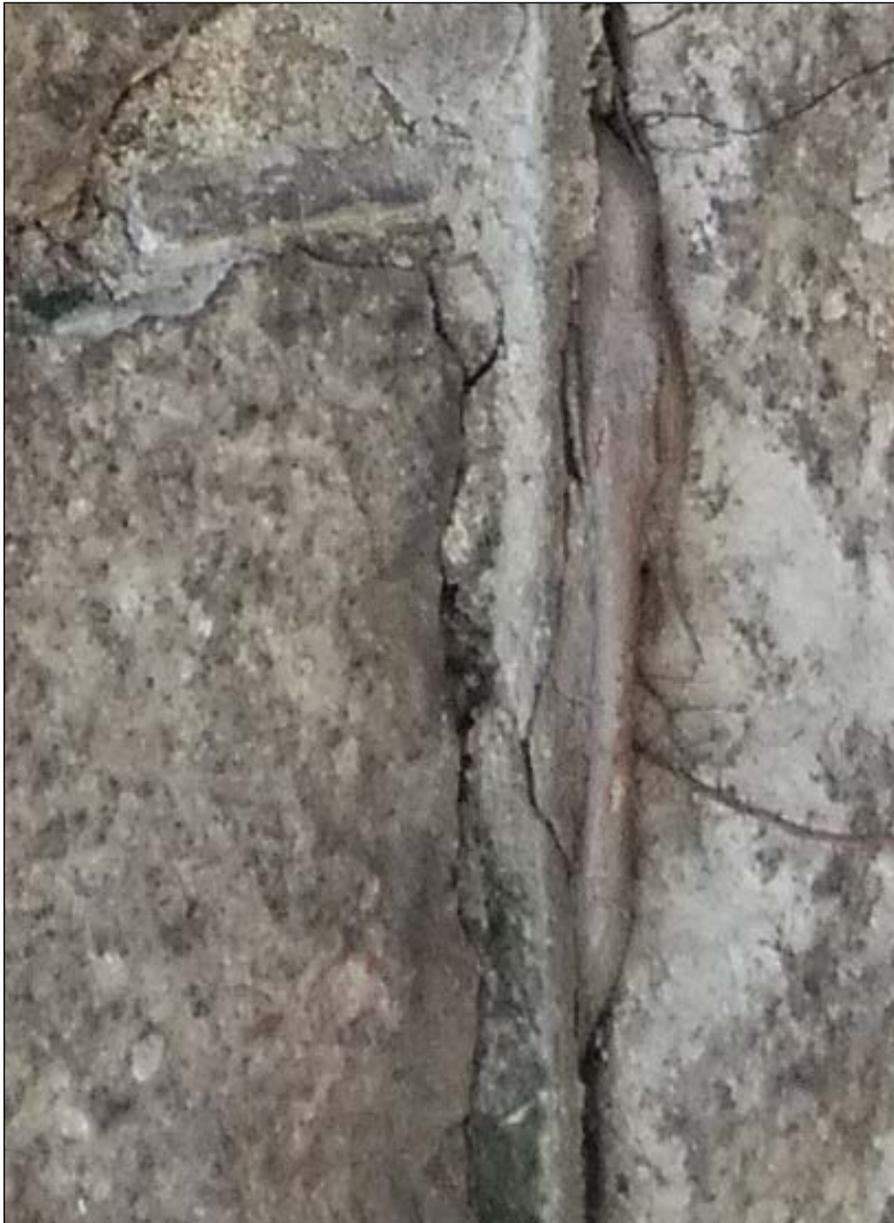
Crack P.2 (2015-08-05)

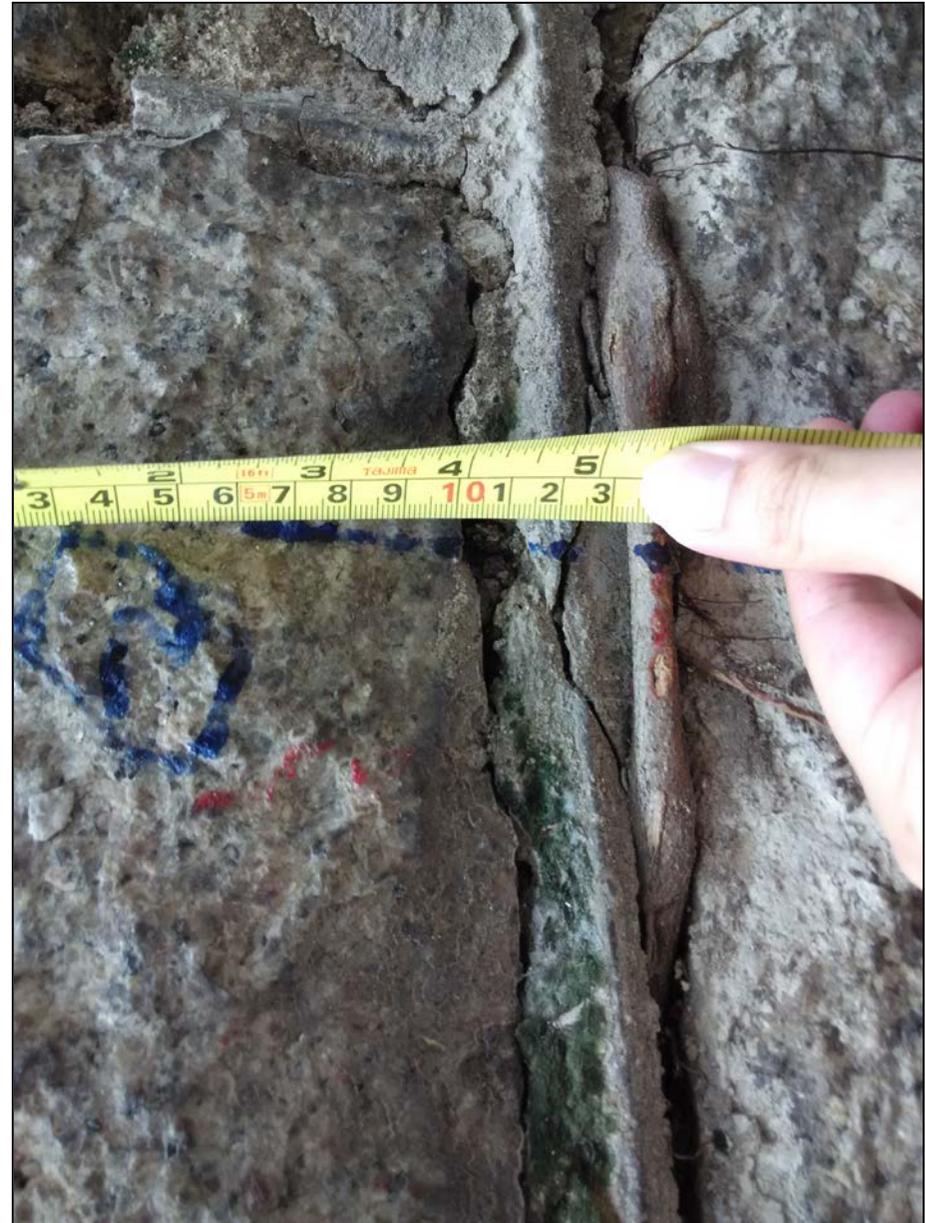
Crack P.2 (2015-08-06)

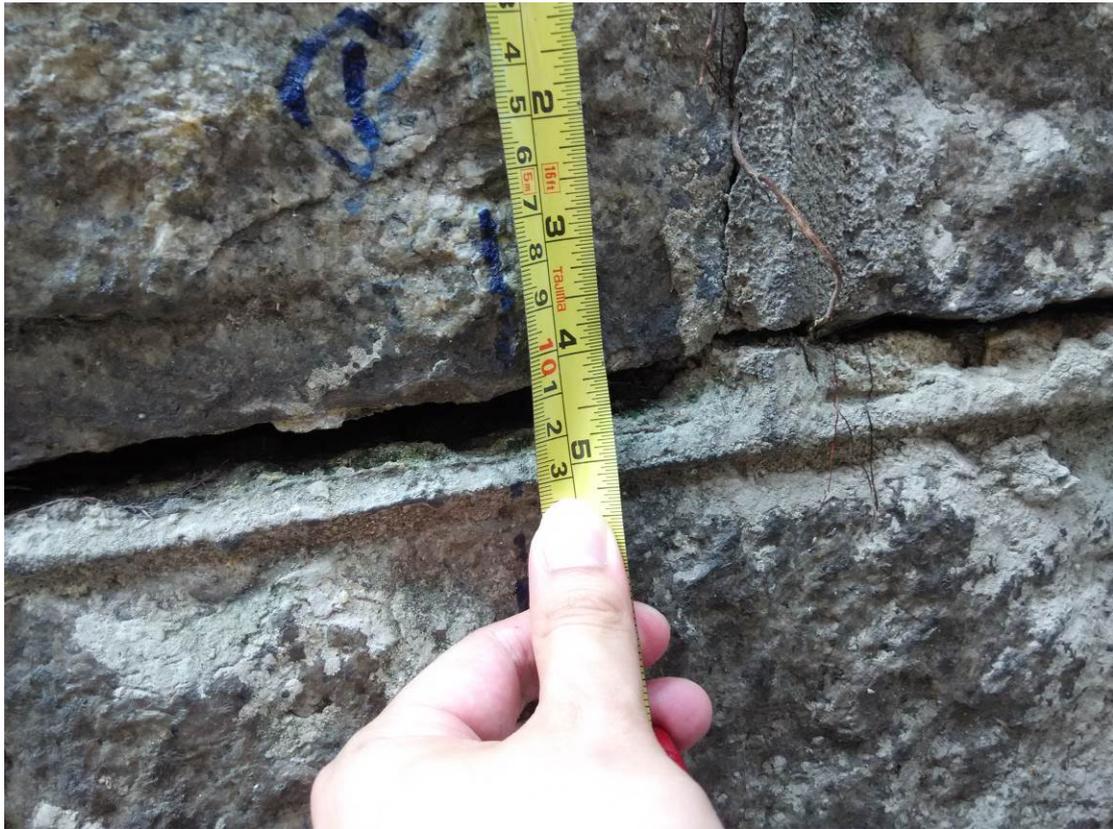
Crack P.1 – 24mm

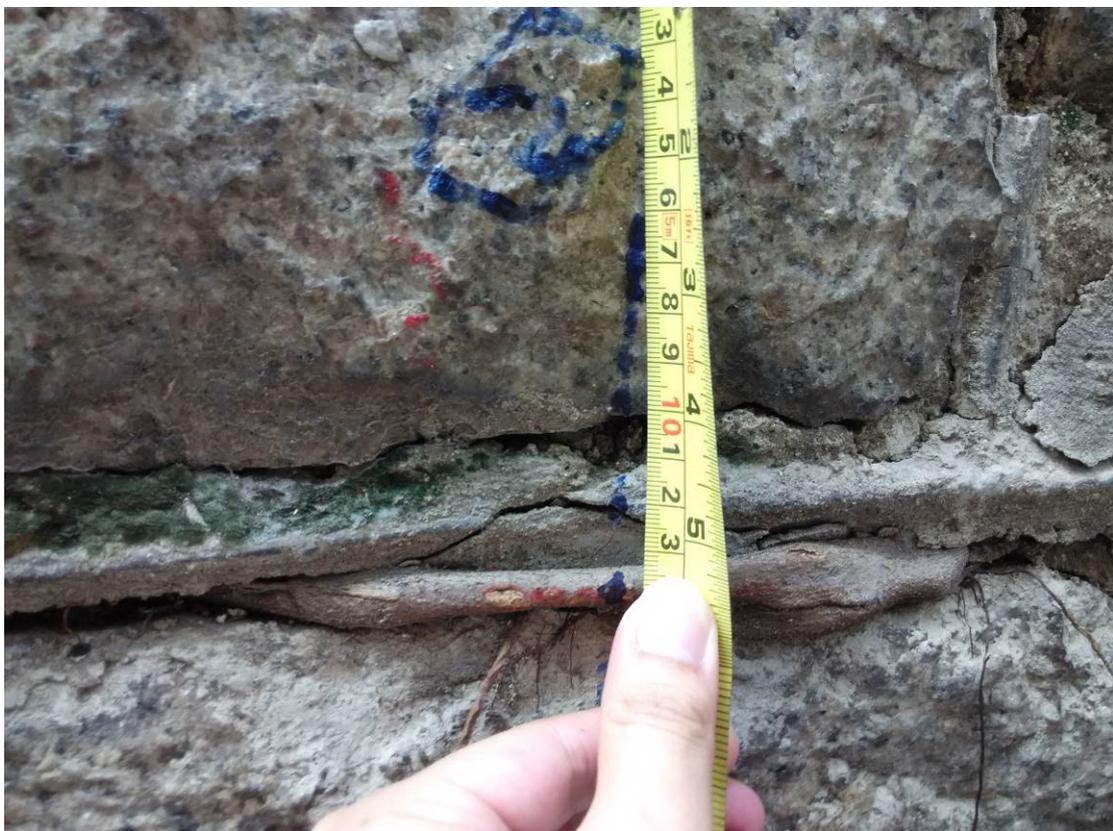
Crack P.2 – 10mm

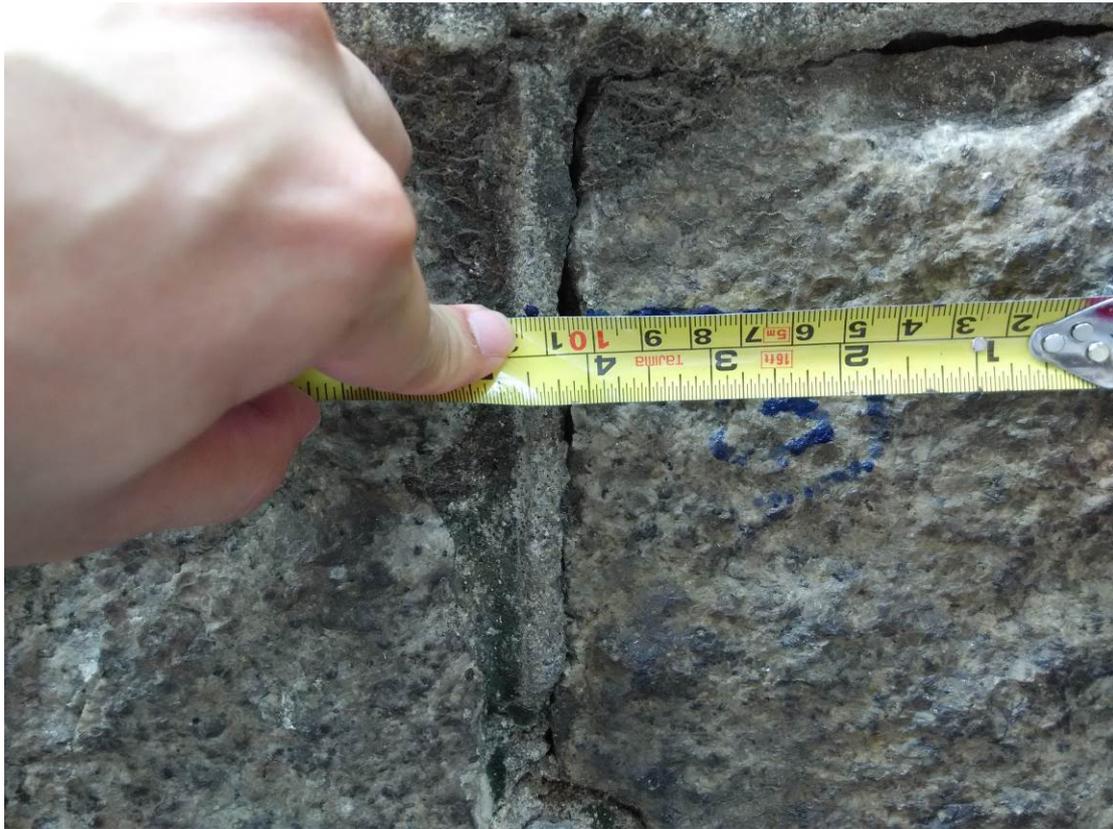
Crack P.3 – 5mm

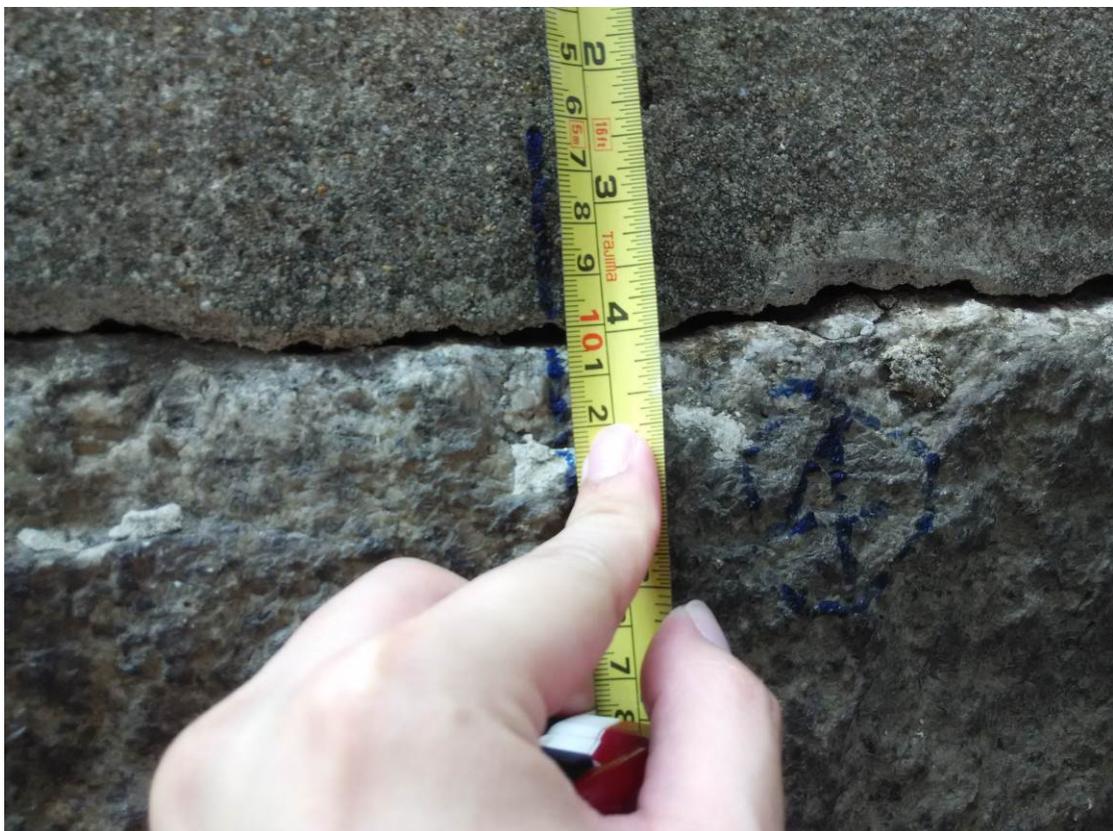
Crack P.4 – 5mm

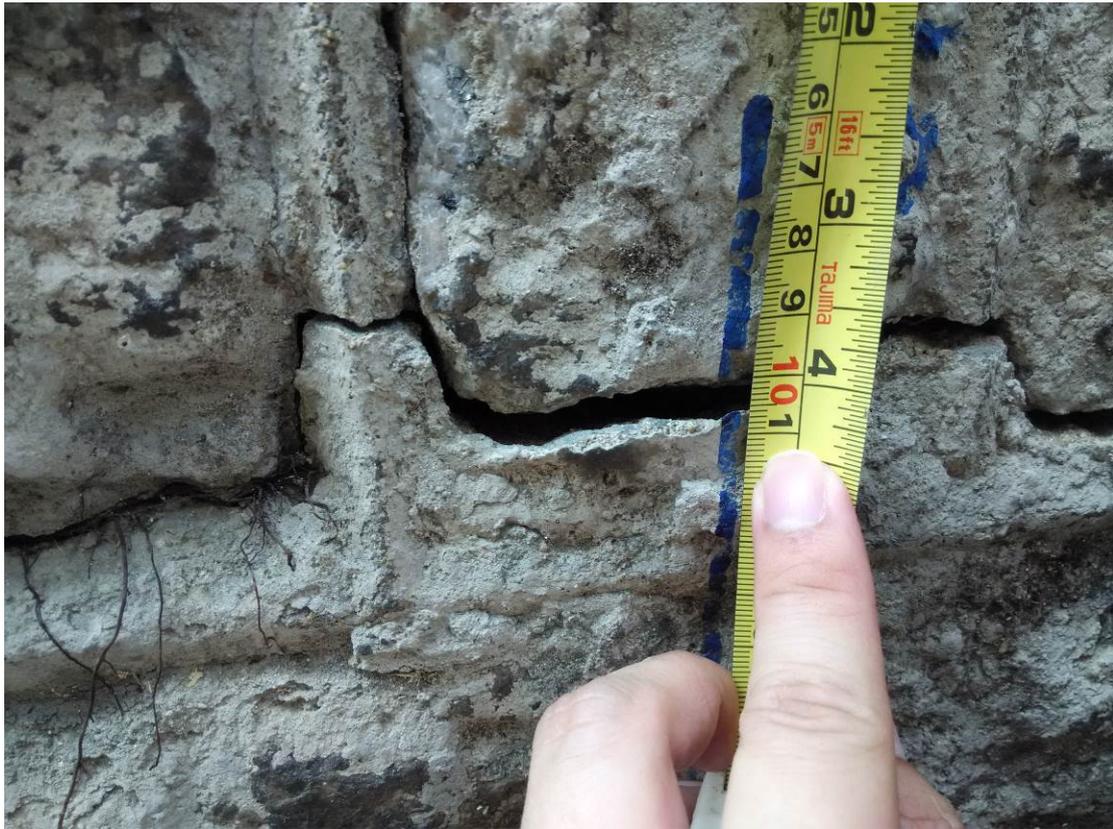
Crack P.5 – 6mm

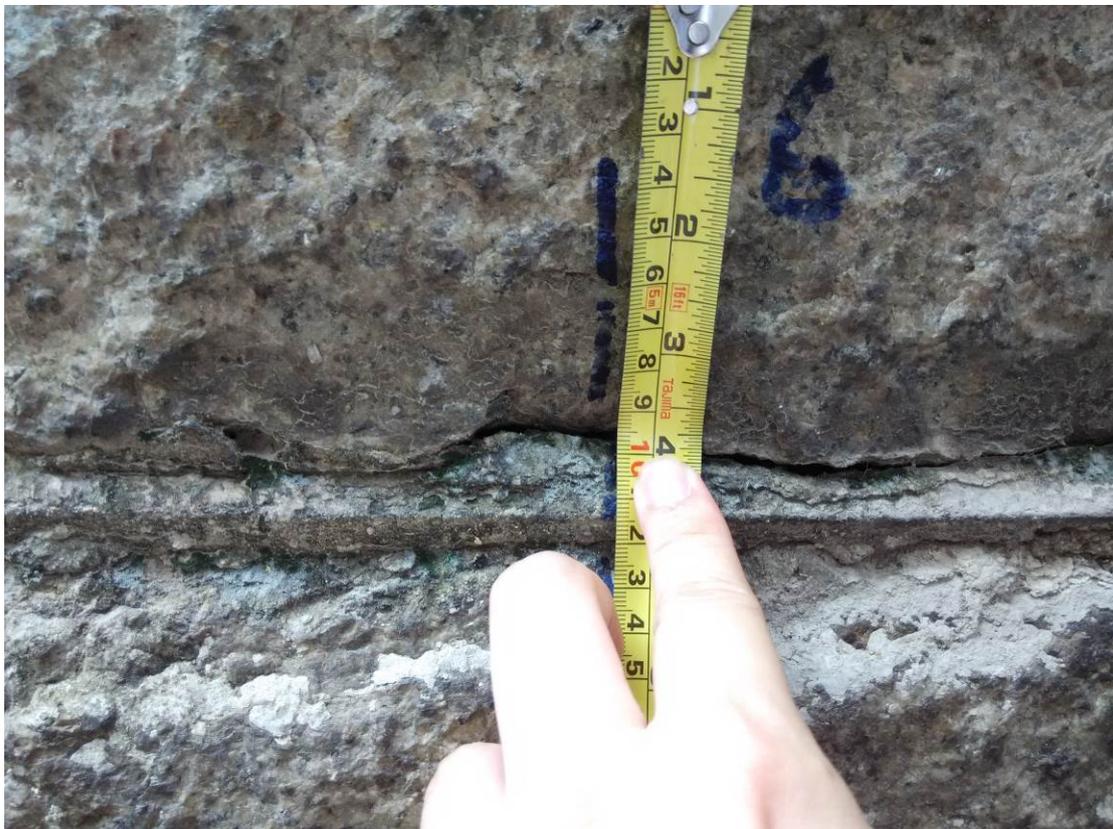
Crack P.6 – 3mm

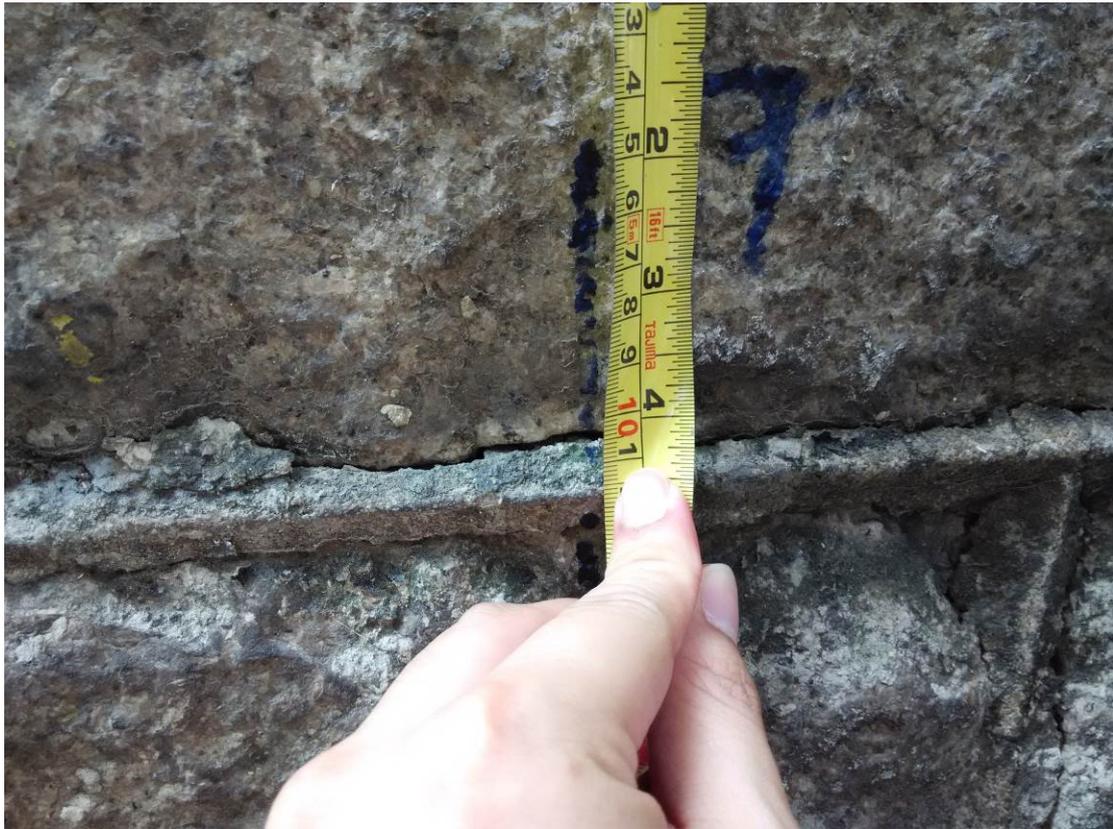
Crack P.7 – 3mm
