Report on Emergency Felling of Stonewall Trees on Slope No. 11SW-A/R577 at Bonham Road / St Stephen's Lane on 7 August 2015

Highways Department
August 2015

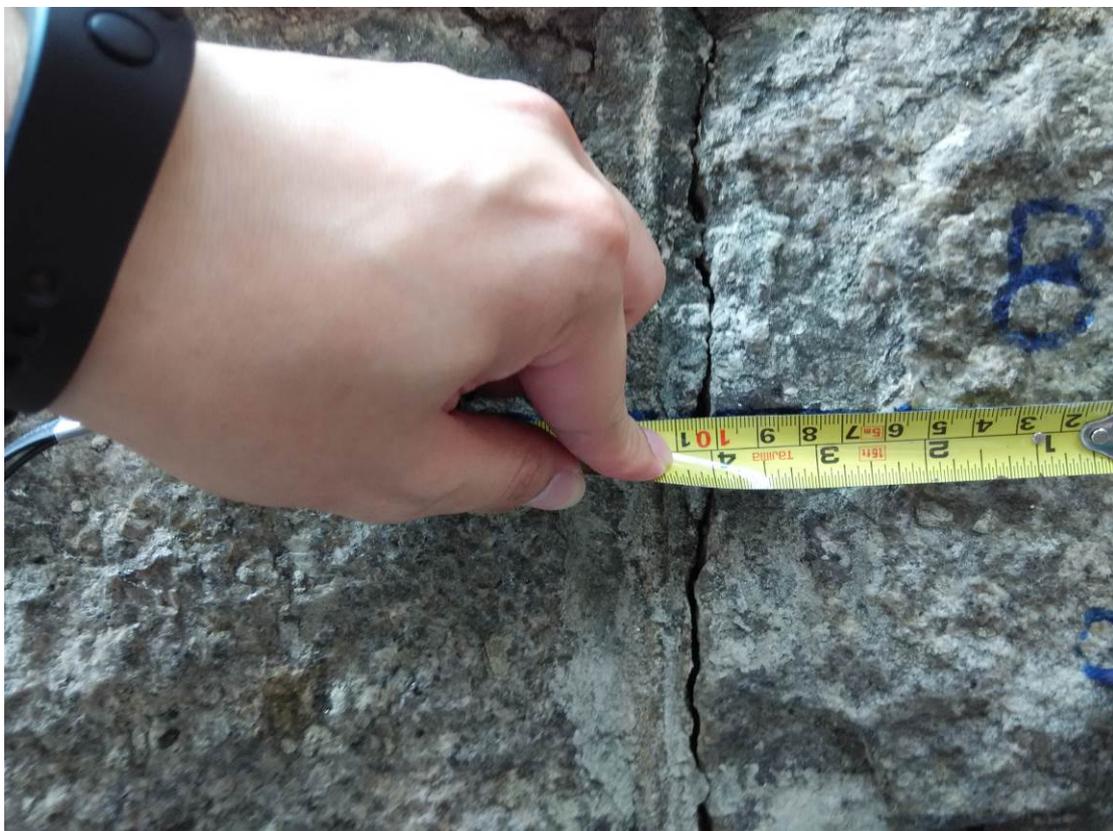
Crack P.8 – 5mm

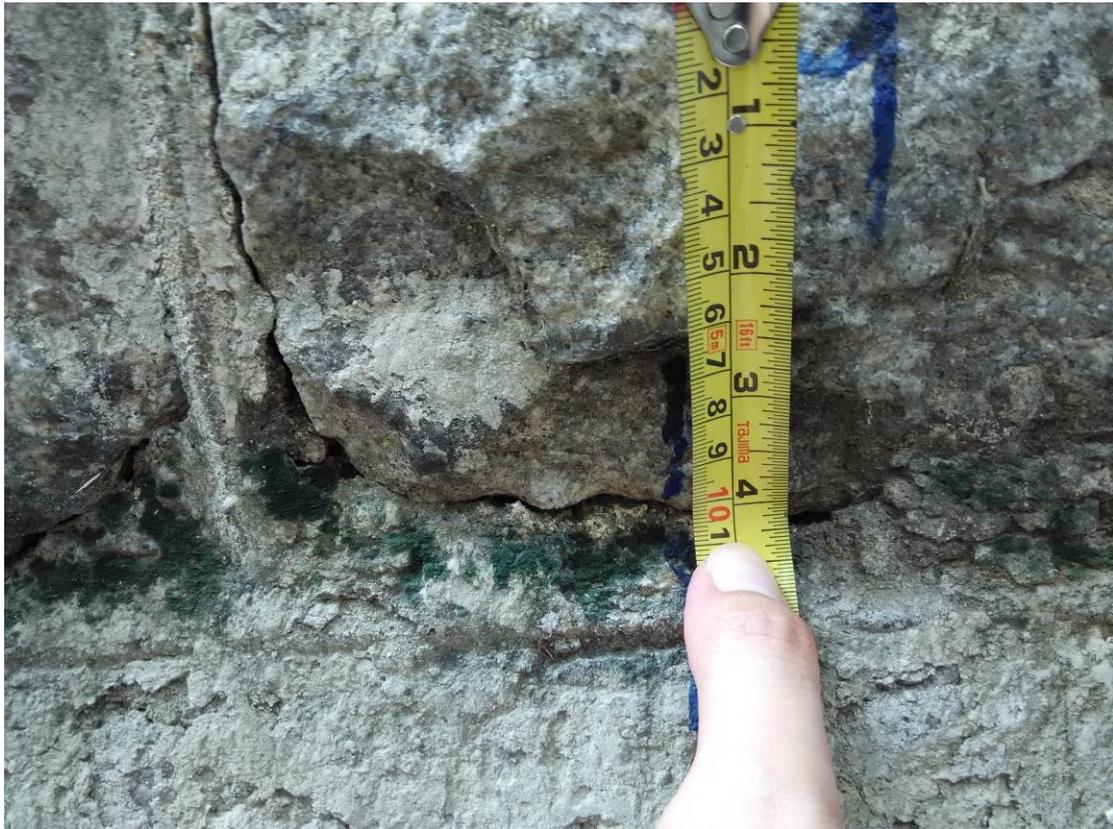
Crack P.9 – 2mm

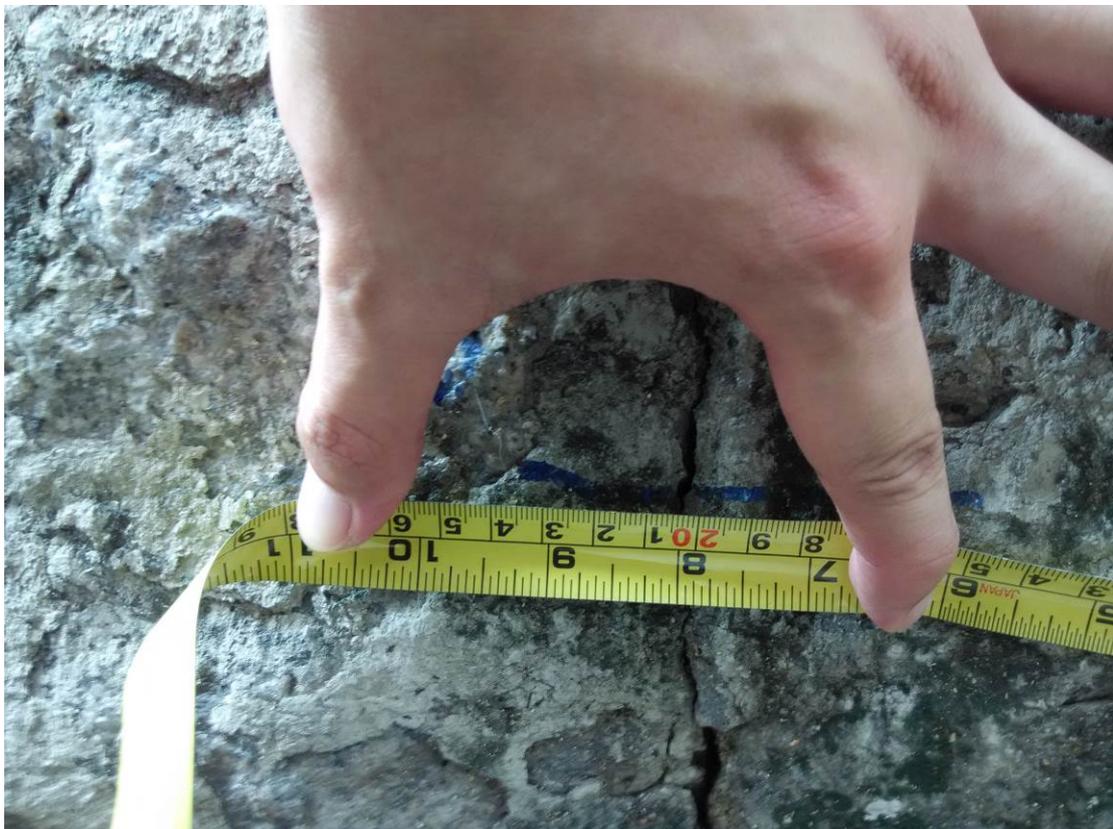
Crack P.10 – 5mm

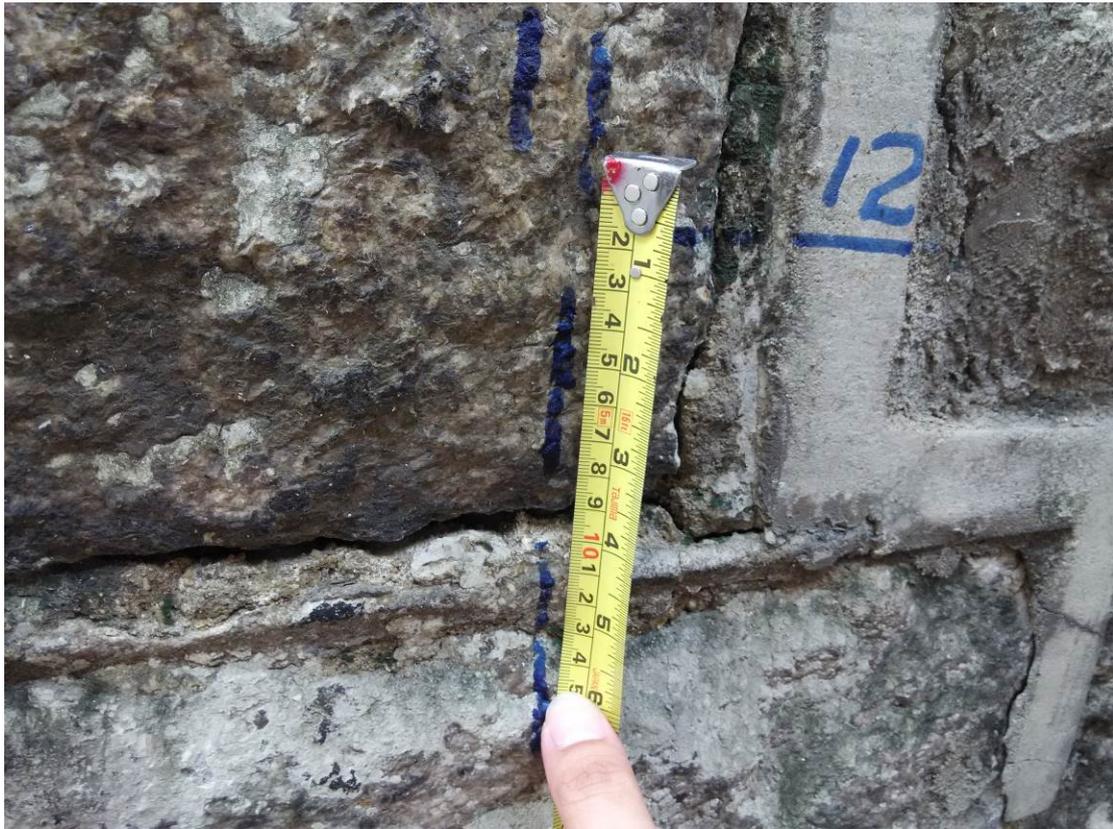
Crack P.11 – 10mm

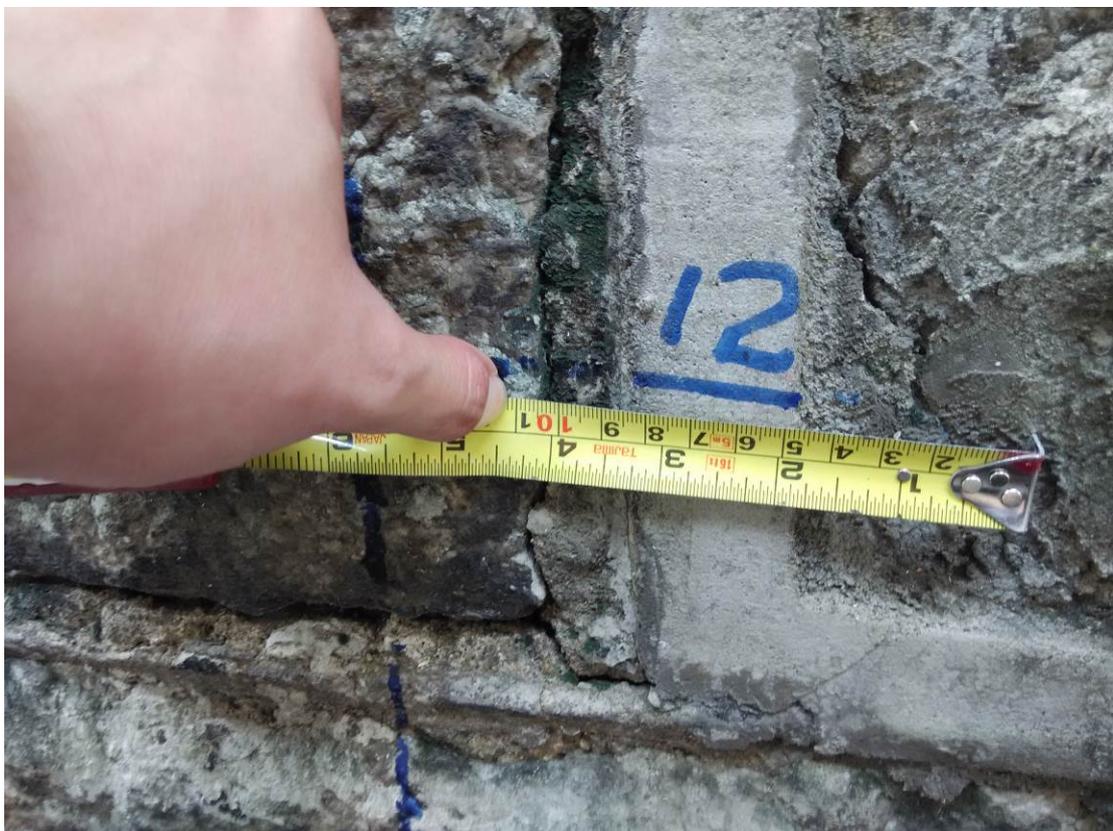
Crack P.12 – 2mm

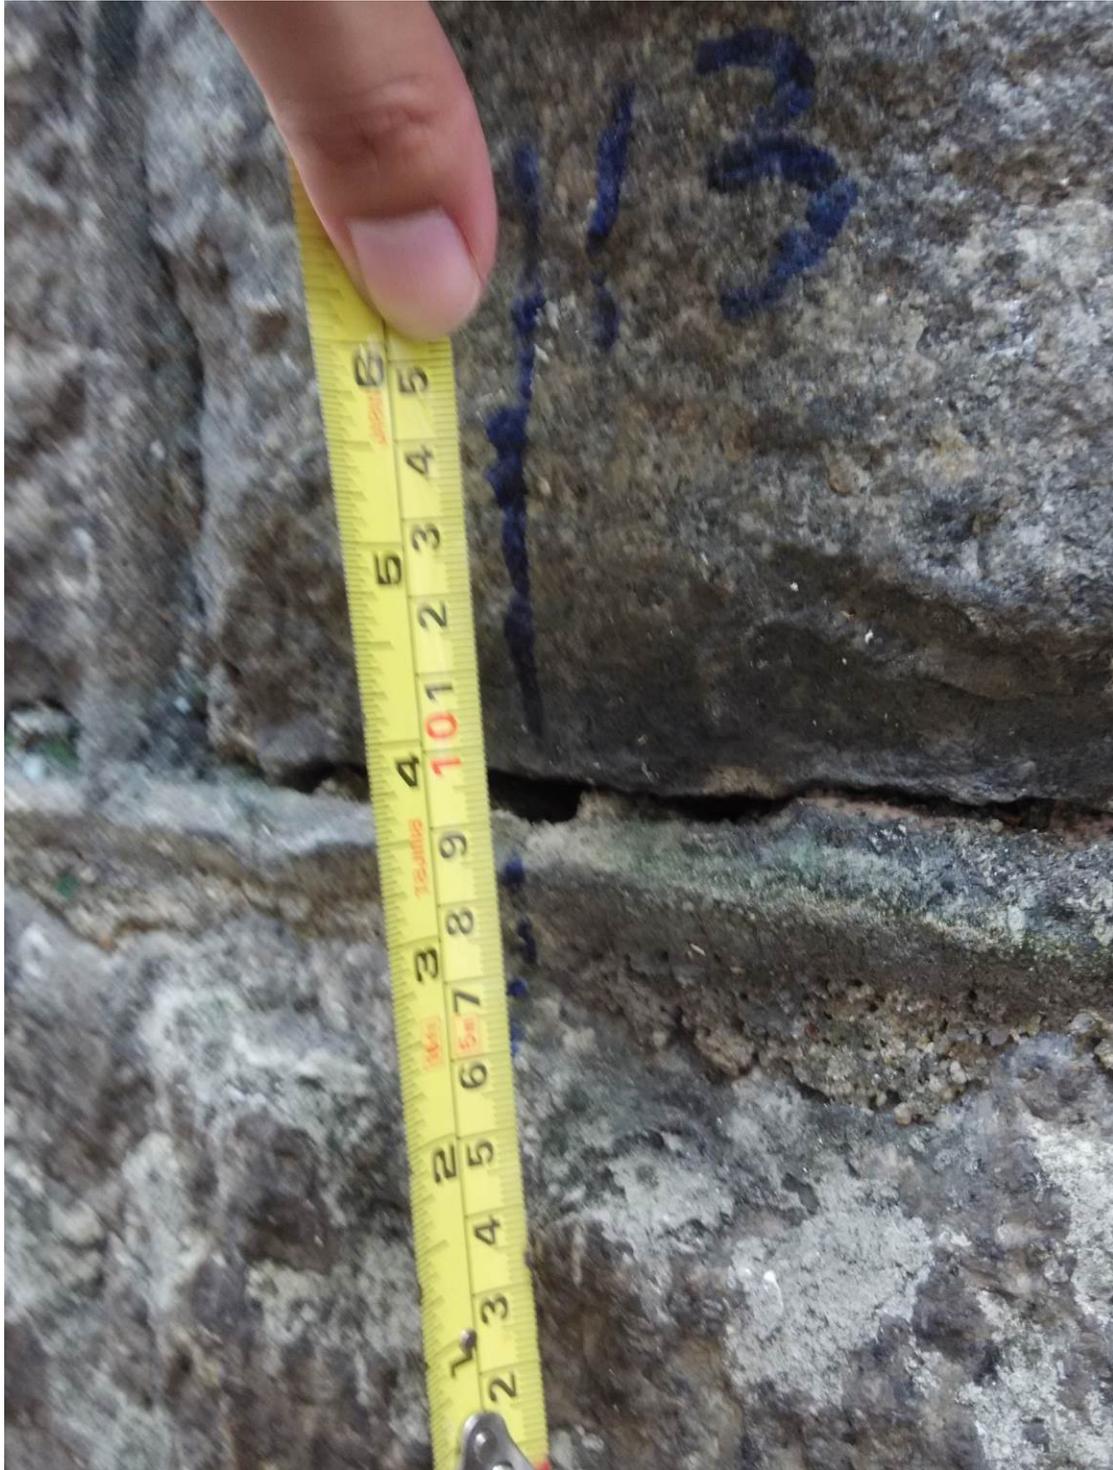
Crack P.13 – 8mm

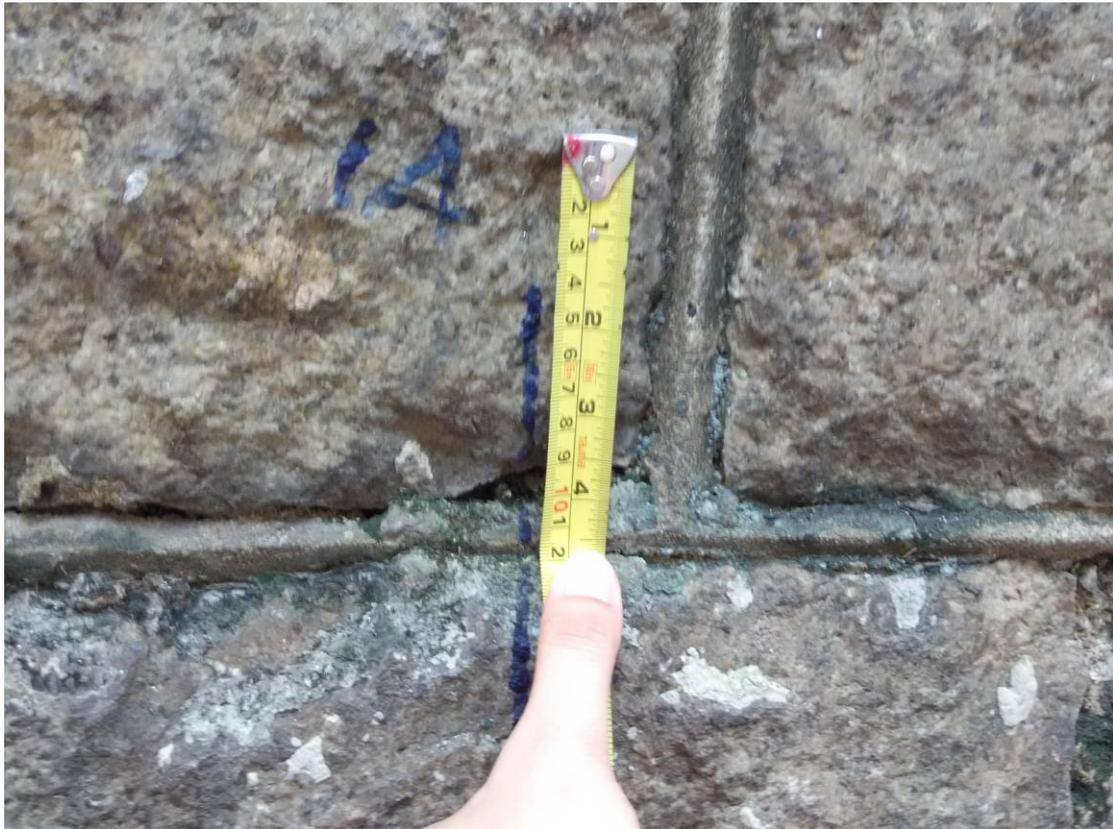
Crack P.14 – 12mm

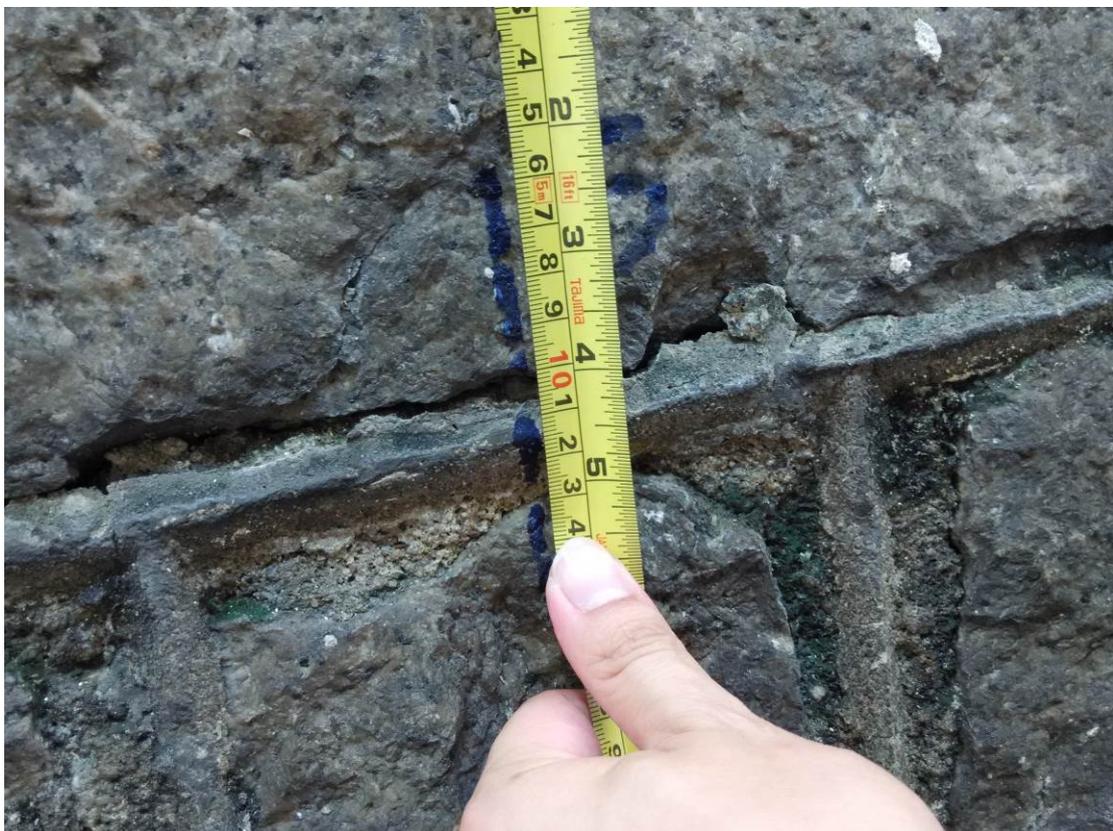
Crack P.15 – 10mm

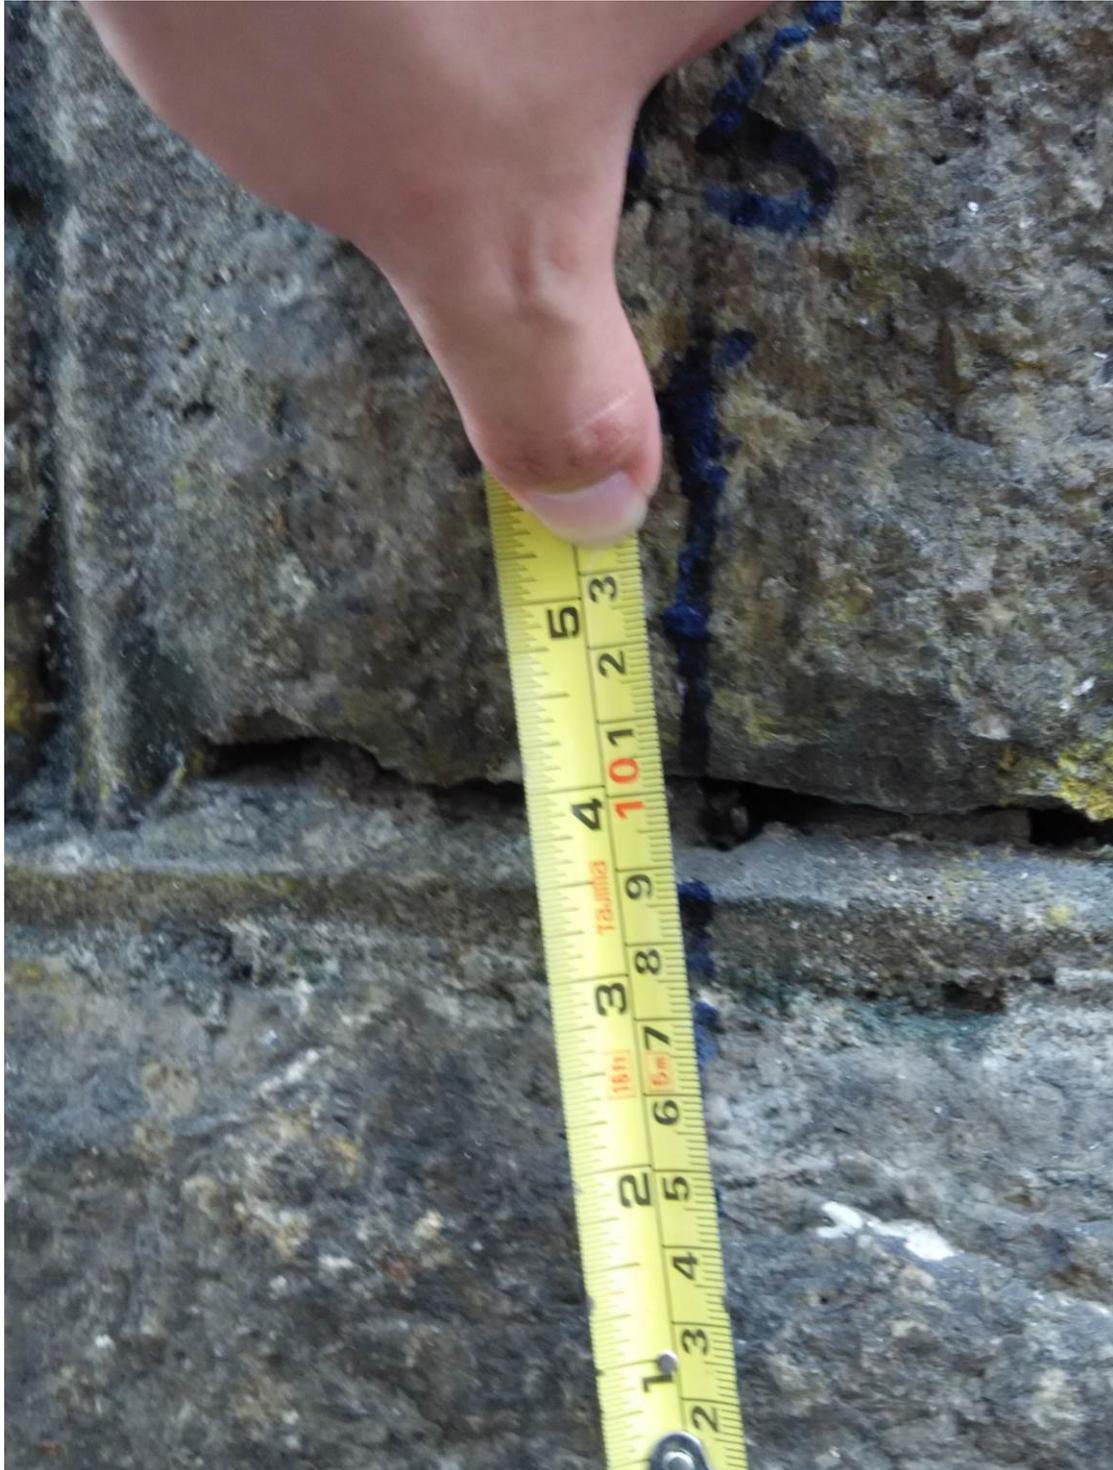
Crack P.16 – 14mm

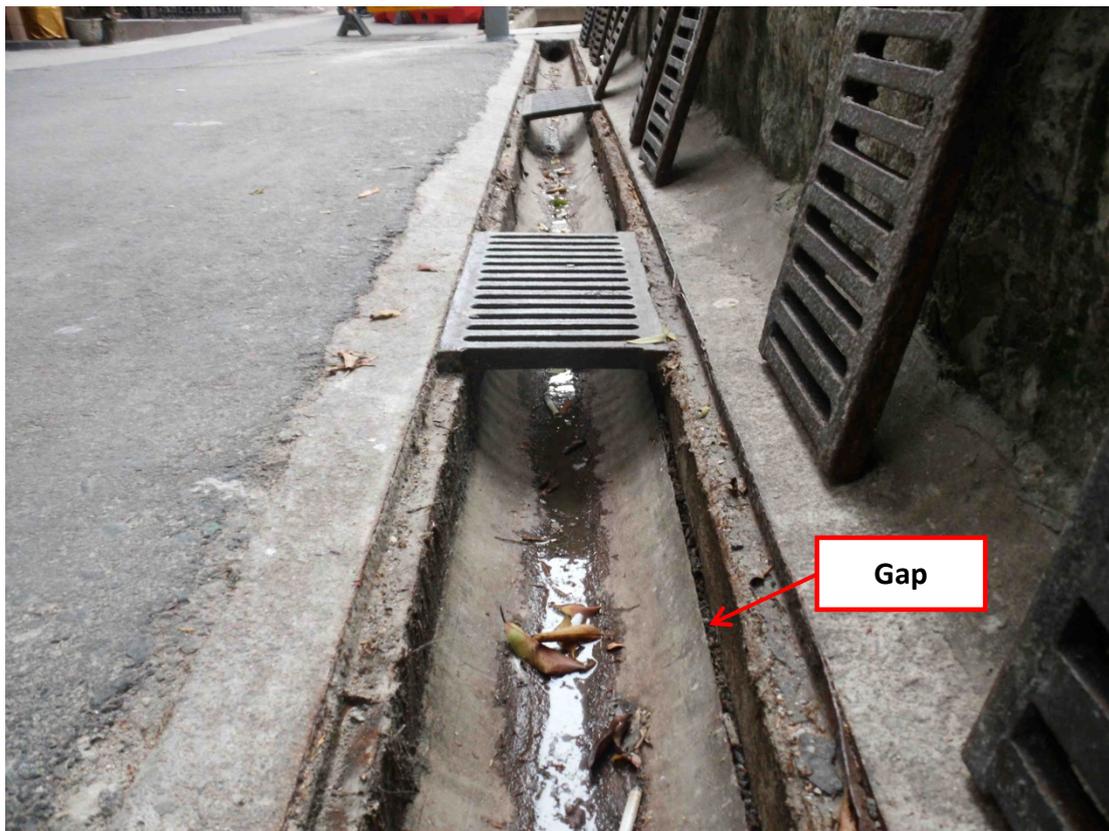
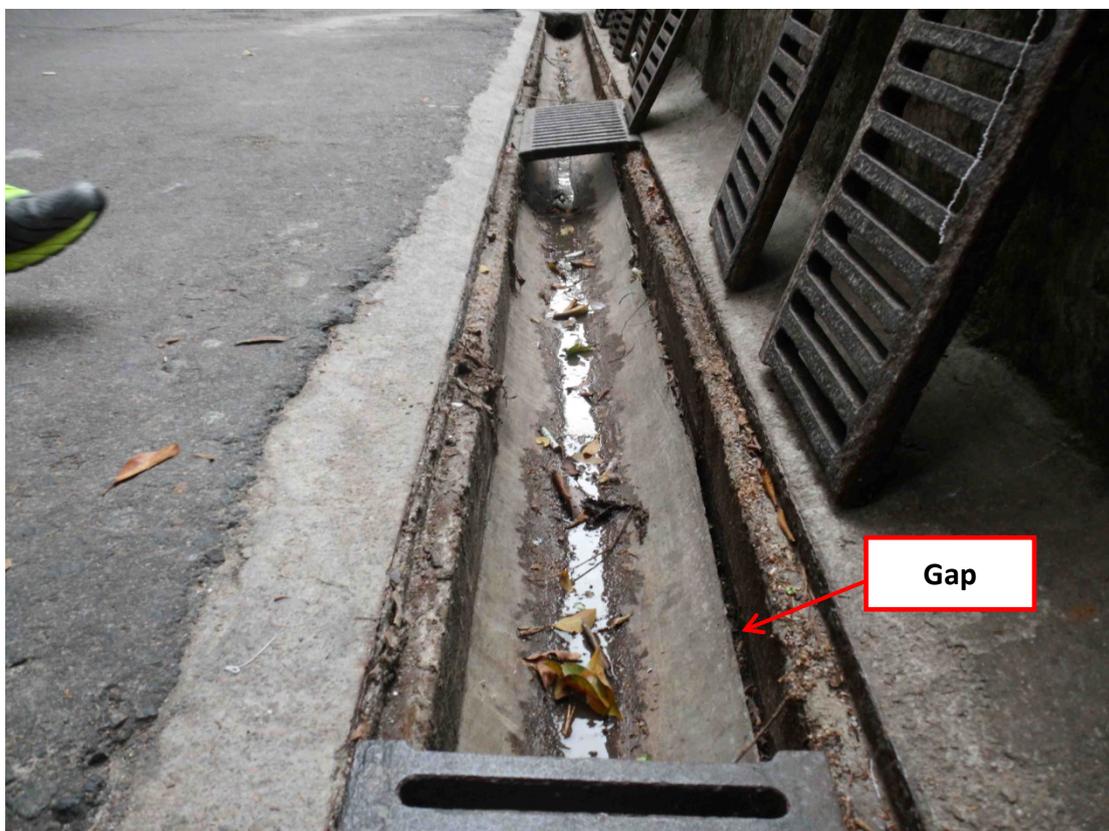
- 4.7 On 7 August 2015, HyD, TMO and GEO carried out a joint site inspection to further assess the situation. The crack condition was rechecked and crack width reconfirmed. Moreover, at the U-channel nearby the crest of the stonewall at St Stephen's Lane, a longitudinal gap of about 1.5cm wide along the side of the U-channel close to the stonewall was found (Refer to **Diagram 2**). Another longitudinal gap behind the coping of the stonewall where tree T1 was located, as well as a transverse crack cutting through the same coping, were also found. These cracks and gaps were additional to the five cracks noticed previously. Please refer to **Annex 3** for photo records of the gaps.

Record of 15mm wide longitudinal gap found along the side of a U-channel at the coping of stonewall

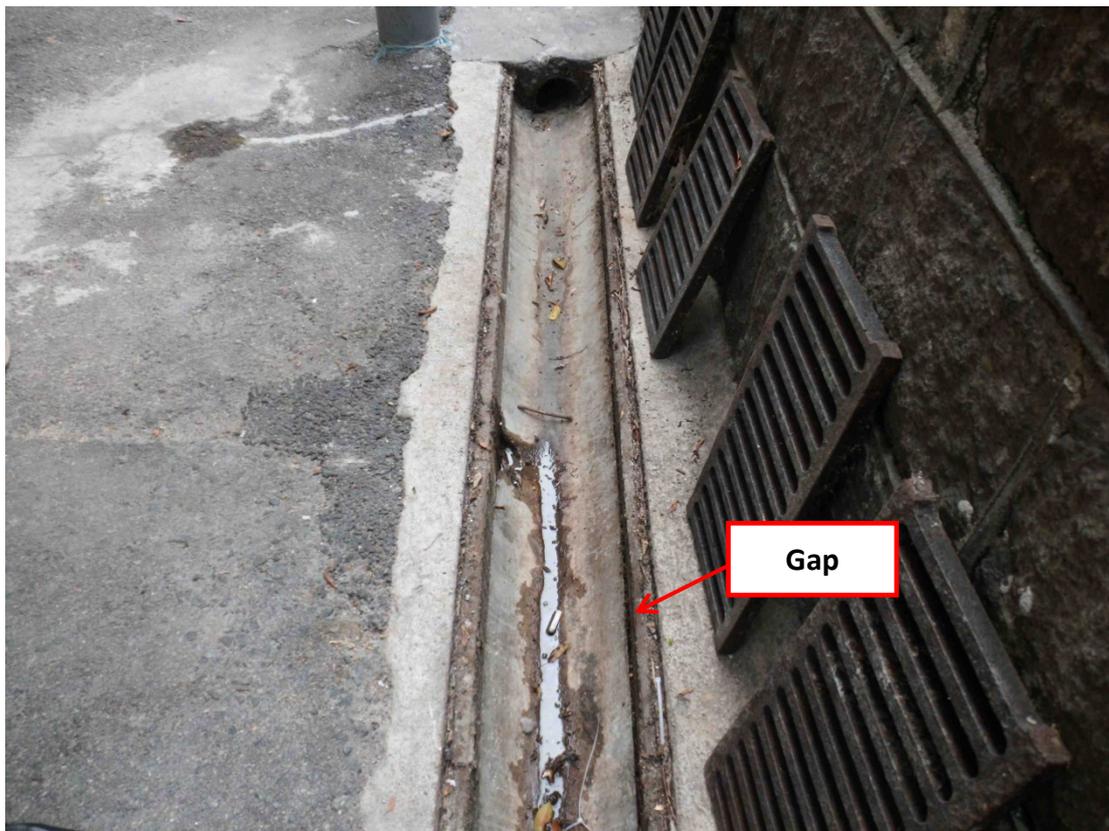
Record of 15mm wide longitudinal gap found along the side of a U-channel at the coping of stonewall

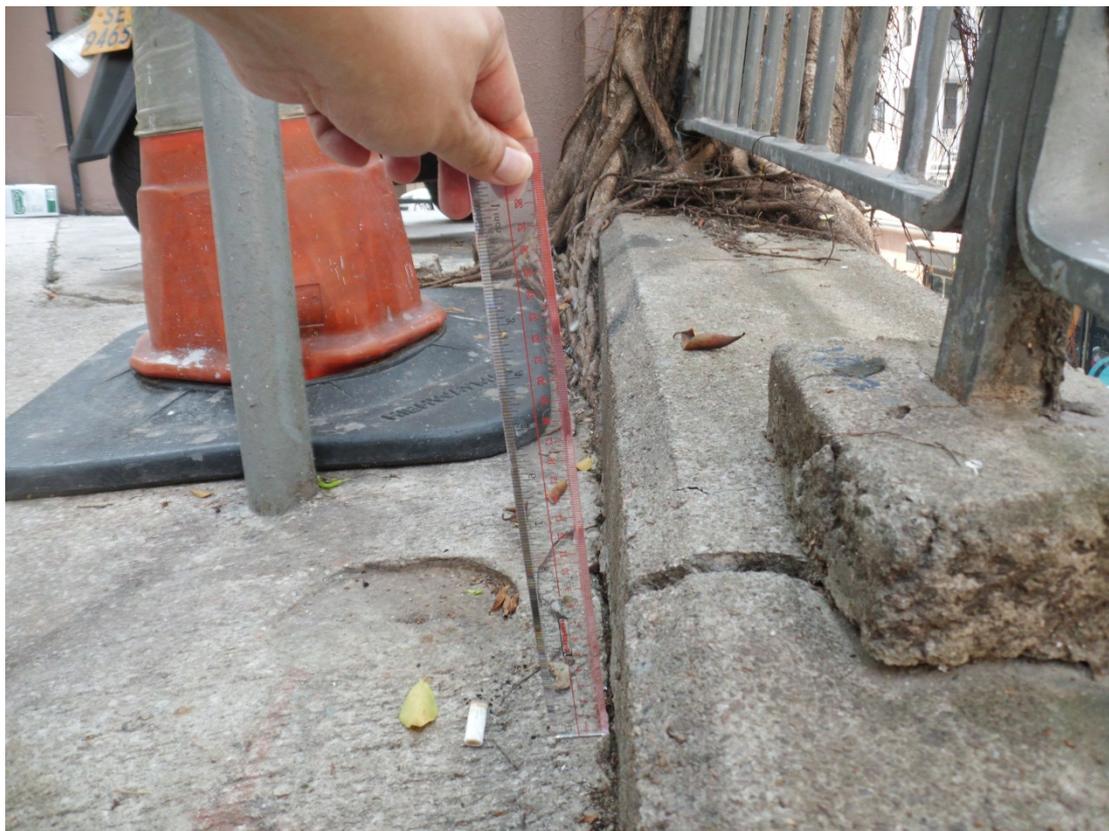
Record of longitudinal gap found along the back of coping of stonewall near tree T1 and transverse crack through the same coping
