**HIGHWAYS DEPARTMENT**

Independent Review on the Procedures for Hong Kong Link Road (Section between Scenic Hill and Hong Kong Boundary Crossing Facilities) - Investigation

**Review Report (FINAL)**

October 2018

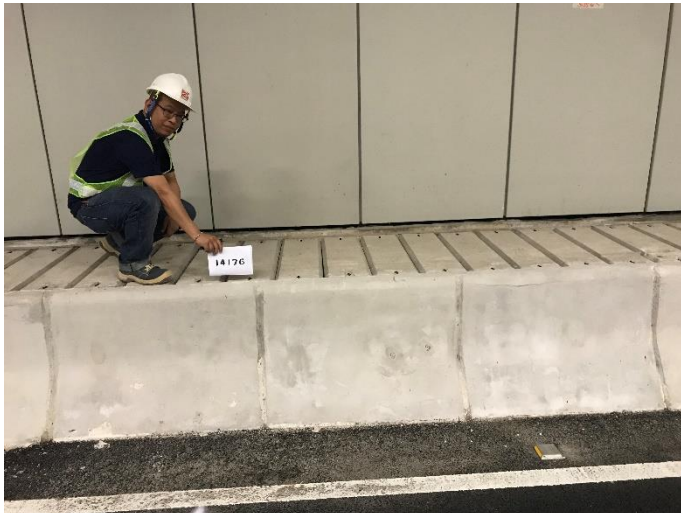
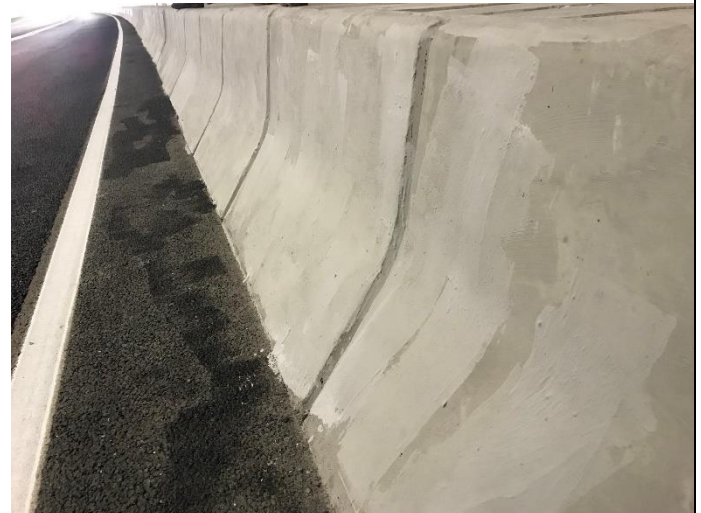
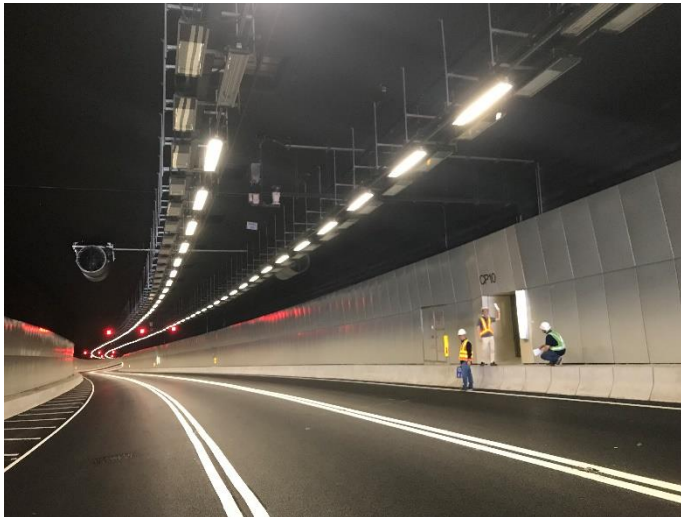
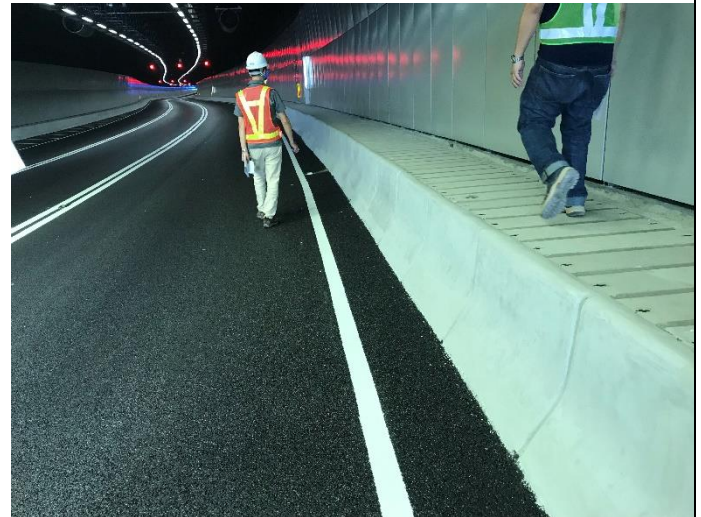
#### Inspection of Profile Barrier

On 4 October 2018, P-KD has carried out visual inspection on superficial conditions of the completed works pertained to the 77 unsettled late-RISCFs. No anomalies on superficial conditions and no sign of distress were observed during the visual inspection. Table 3-11 tabulated the type of completed works and findings of the visual inspection. Photos taken during the visual inspection are appended in **Appendix D** for reference.

TYPE OF INSPECTION SPECIFIED IN THE UNSETTLED RISCFs AND TYPE OF COMPLETED WORKS	FINDINGS OF VISUAL INSPECTIONS
Rebar Fixing for Profile Barrier	No anomalies were observed during visual inspection on superficial conditions of the completed works on 4 Oct 2018.
Concreting for Profile Barrier	
Installation of VE Panel	
Installation of Cable Hanger at Utilities Trough	
Installation of Cable Hanger at Wall	
Formwork for Manhole	
Rebar Fixing for Manhole	
Concreting for Manhole	
Application of Black Paint
