## STONEWALL TREE MANAGEMENT A MULTI-DISCIPLINARY APPROACH

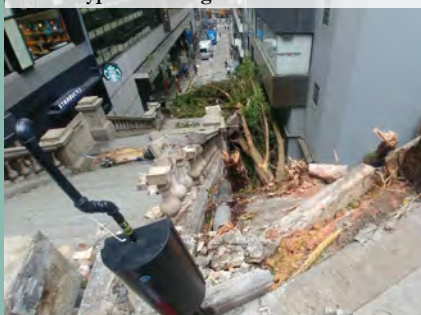
There is a limit as to what man can do, especially when compared to the power of nature. During super typhoon Mangkhut struck Hong Kong in 2018, a SWT close to the Duddell Street Steps collapsed under the strong wind, damaging three of the four century-old gas-powered street lamps in proximity, as well as part of the historical granite steps. Due to the SWTs' delicate structural equilibrium, their ability to withstand wind is often lower than that of their counterparts growing on ground. While preserving them is our mission, we should also be reminded of their potential risks of collapsing and our responsibility of ensuring public safety.

■ After typhoon Mangkhut's attack

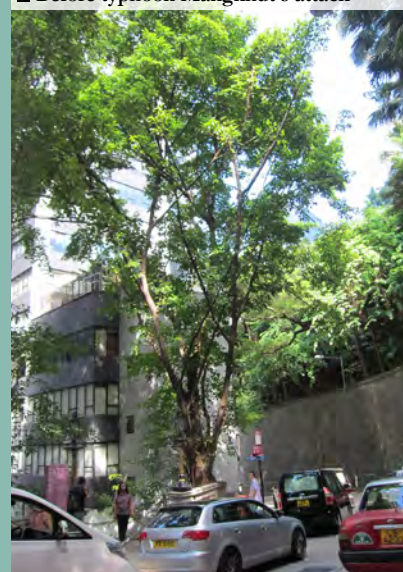
## SWT AT DUDELL STREET

■ Before typhoon Mangkhut's attack

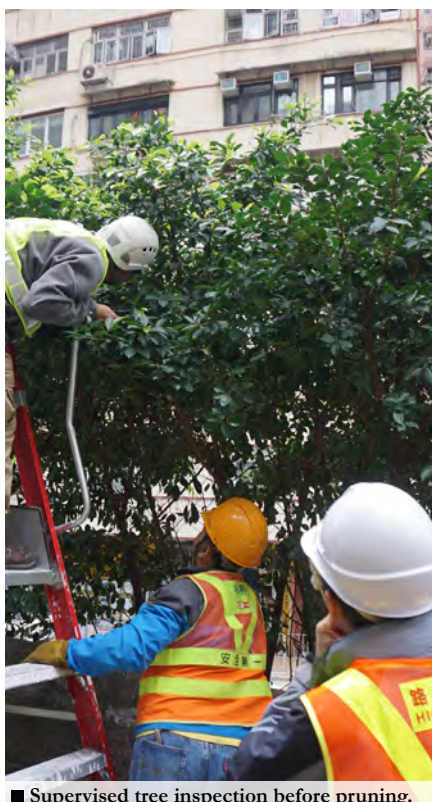
■ Supervised tree inspection before pruning.

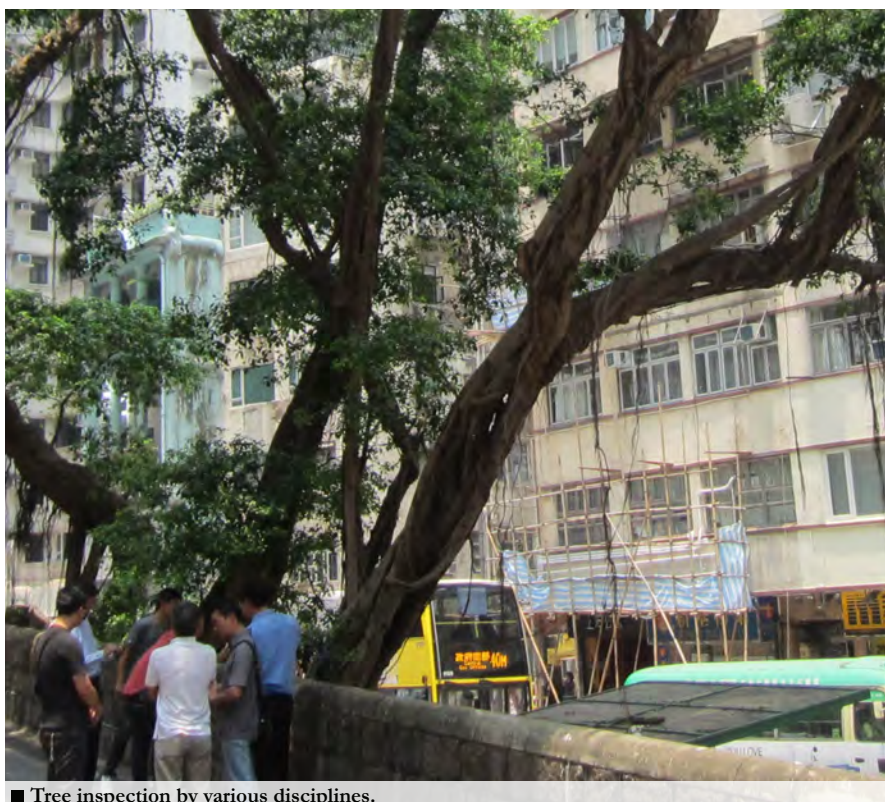
■ Tree inspection by various disciplines.

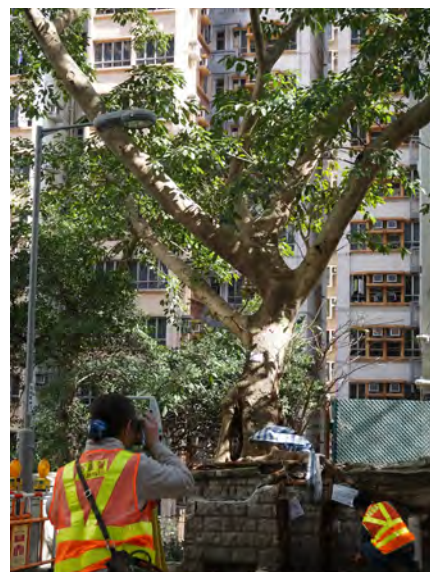
■ Monitoring of SWT using total station by radiation method.

Monitoring survey on tree movement or displacement is also conducted by our land surveyors and survey officers. The position of multiple selected marks on tree trunk are surveyed periodically to detect tree displacement for early mitigating actions.

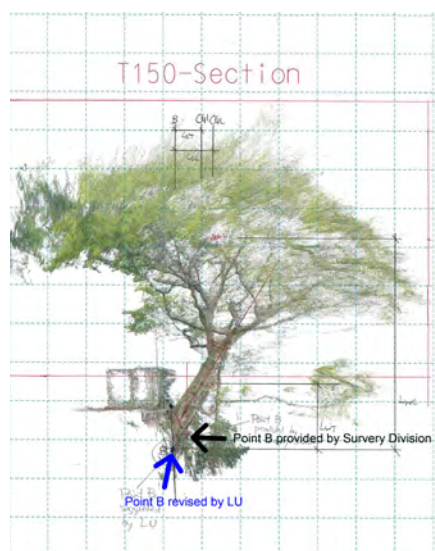
■ Cross-section of laser scanned SWT model.

Close range photogrammetry and laser scanning survey are as well done to monitor our SWTs. After data processing, a 3D model could be generated for each SWT to facilitate further monitoring of canopy changes and planning of the extent of tree pruning. To ensure the stability of stonewalls, our surveyors also monitor the stonewall and its cracks, if any, for any changes.

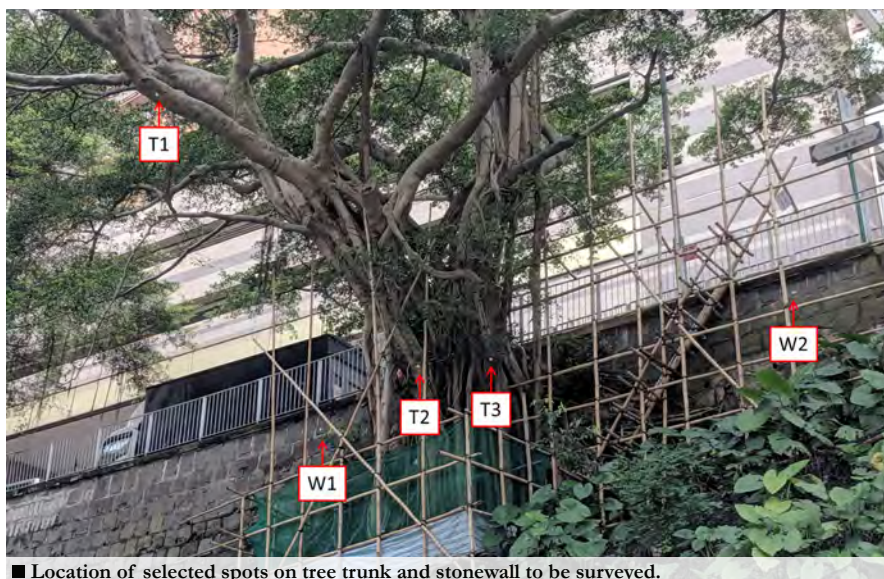
■ Location of selected spots on tree trunk and stonewall to be surveyed.

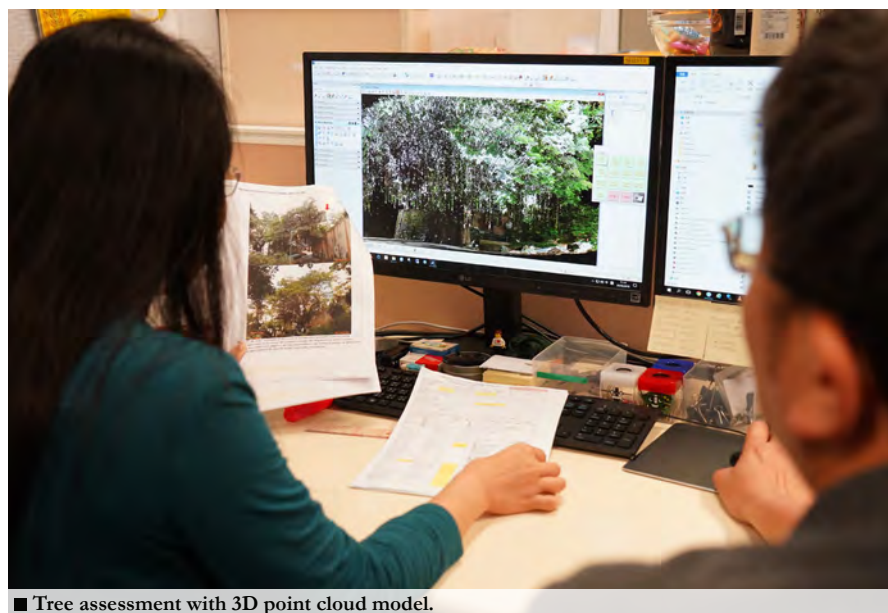
■ Tree assessment with 3D point cloud model.

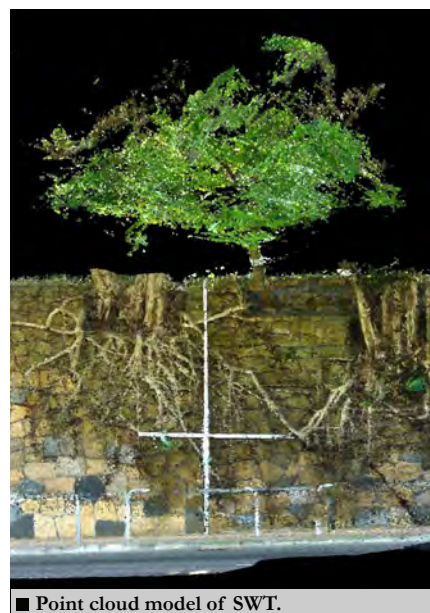
■ Point cloud model of SWT.

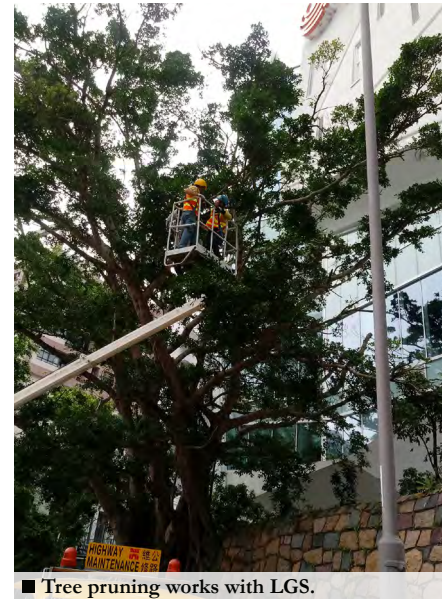
■ Tree pruning works with LGS.

As one of the means to alluviate the risks derived from the risk assessments, pruning is done to reduce the crown size and tree height, thus reducing the weight of the crown itself as well as the wind load acting on the tree. The extent of pruning is determined by the engineering analysis derived from the Tree Trunk Failure Analysis and Tree Anchorage Shallow Failure - Sensitivity Analysis.

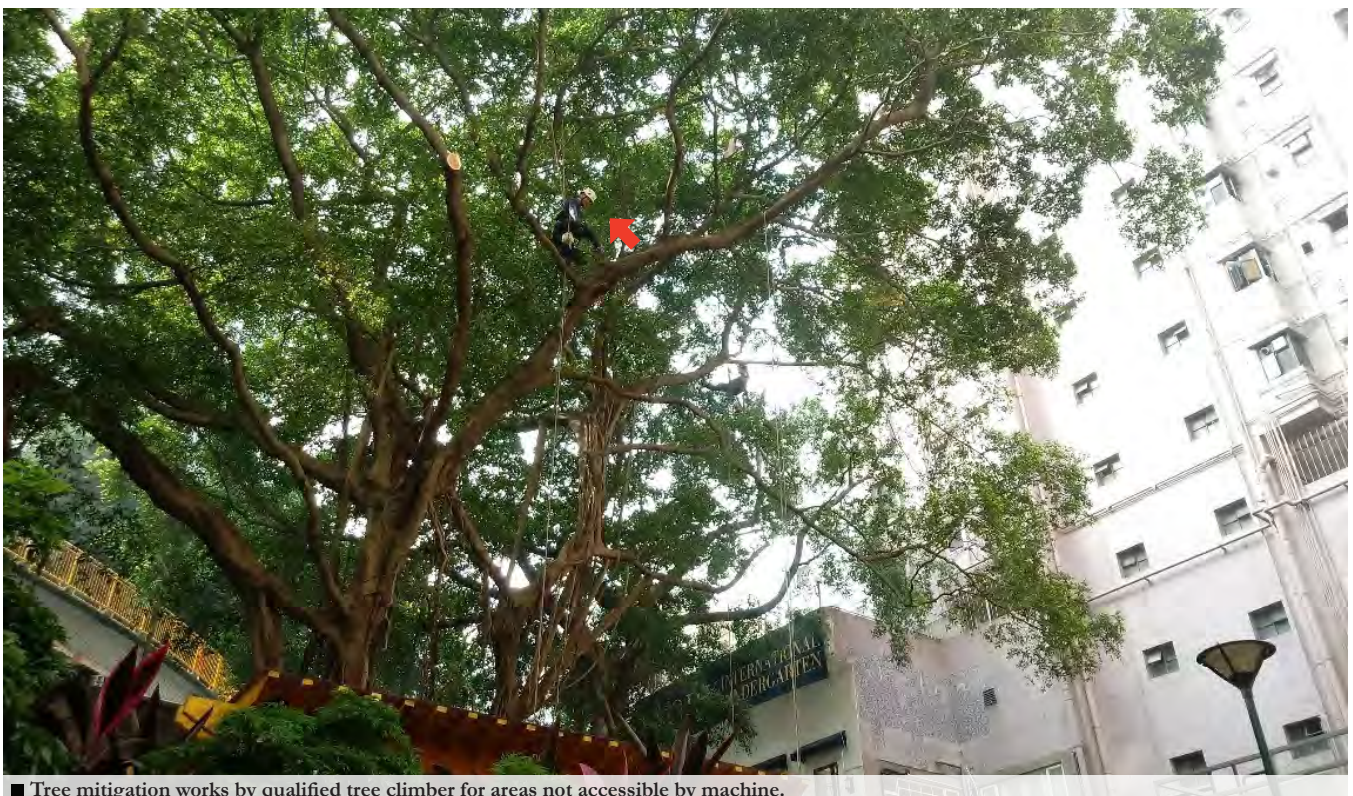
■ Tree mitigation works by qualified tree climber for areas not accessible by machine.

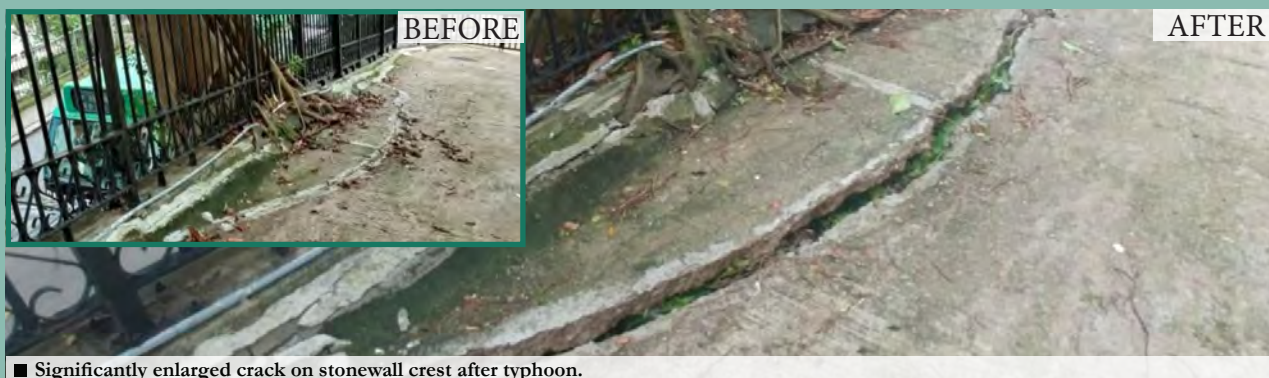
■ Significantly enlarged crack on stonewall crest after typhoon.

A SWT on Lower Albert Road was under our constant monitoring. The changes in size of the cracks on the stonewall's top and surface have been monitored and recorded. Soon after Typhoon Mangkhut's attack in 2018, engineering staff noticed the significant enlargement of cracks on the stonewall near the base of the SWT on Lower Albert Road. Upon inspection, our multi-disciplinary team found that the SWT was in imminent danger of failure. As its failure would lead to catastrophic consequences and due to the lack of other practicable mitigating means, the team concluded that there was a need to arrange urgent removal of the SWT. The team then liaised with tree experts and the TMO to discuss on arboricultural works, and consulted the District Officers, the District Council and other stakeholders. Prompt arrangements were made in collaboration with the Police, the Transport Department and the contractor for the removal of SWT. The collaboration of different parties enables us to take timely actions to minimise risks facing the general public.

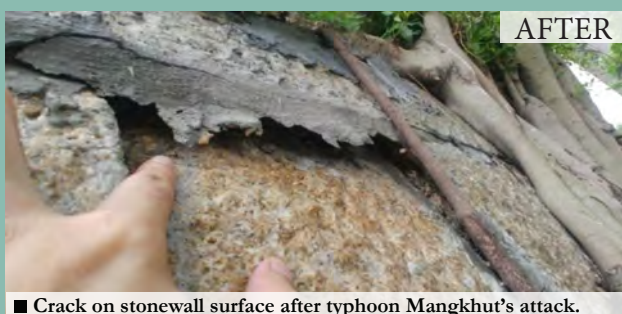
■ Crack on stonewall surface after typhoon Mangkhut's attack.

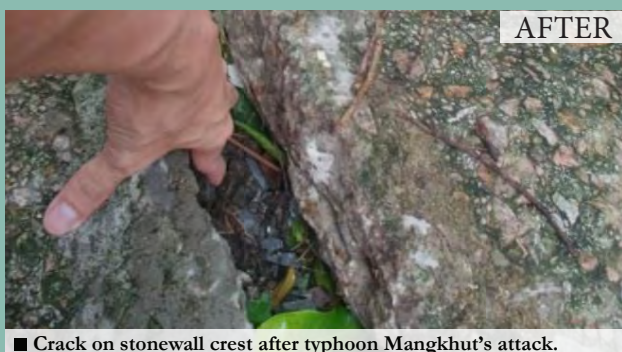
■ Crack on stonewall crest after typhoon Mangkhut's attack.

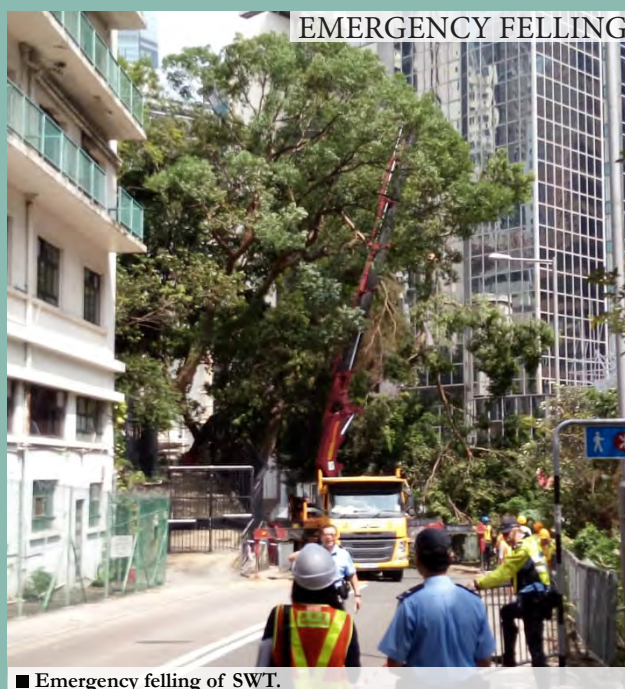
■ Emergency felling of SWT.
