Report on Emergency Felling of Stonewall Trees on Slope No. 11SW-A/R577 at Bonham Road / St Stephen's Lane on 7 August 2015

Highways Department
August 2015

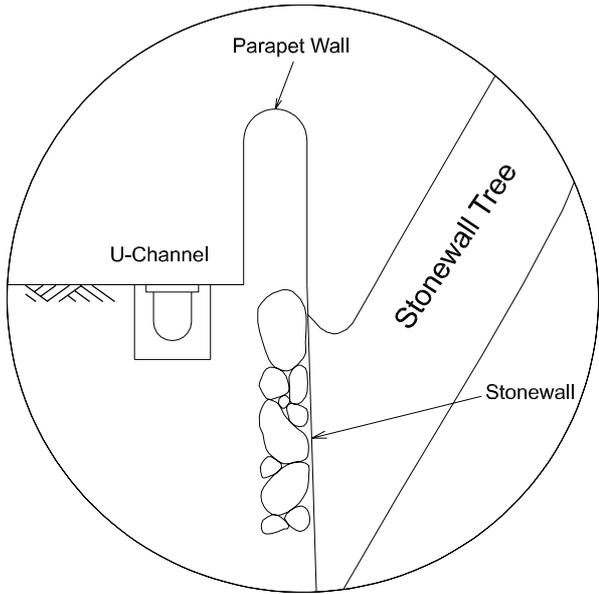
Diagram1

Possible Failure Modes :

- A Tree trunk failure
- B Tree root detachment from stonewall
- C Tree anchorage shallow failure
- D Overall failure
