HIGHWAYS DEPARTMENT

CATALOGUE OF ROAD DEFECTS
(CORD)

Research & Development Division

RD/GN/015B
January 2013

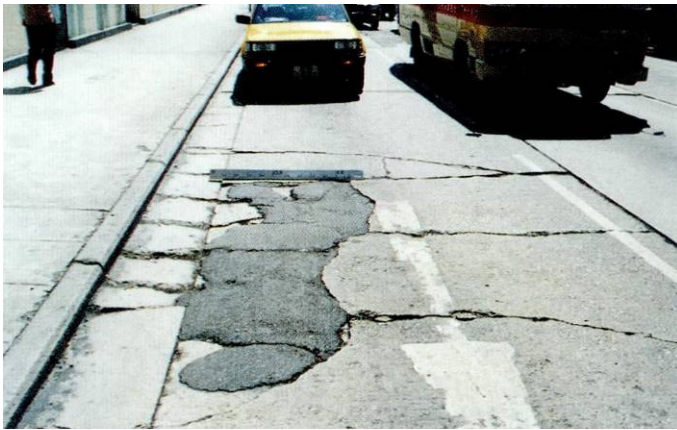
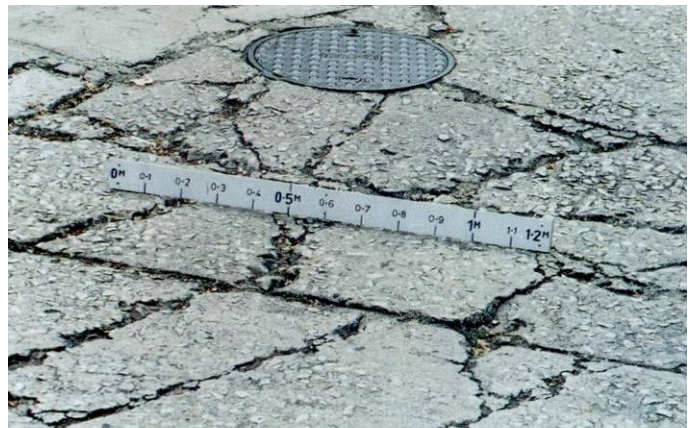
Interconnected cracks forming a series of blocks approximately rectangular in shape, commonly distributed over the full pavement – Plates 1 & 2

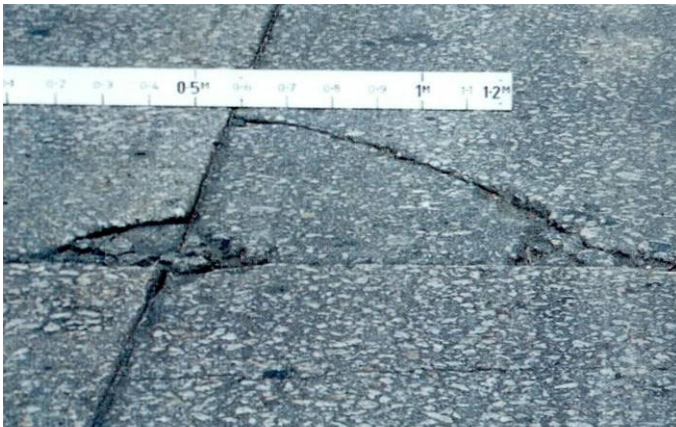
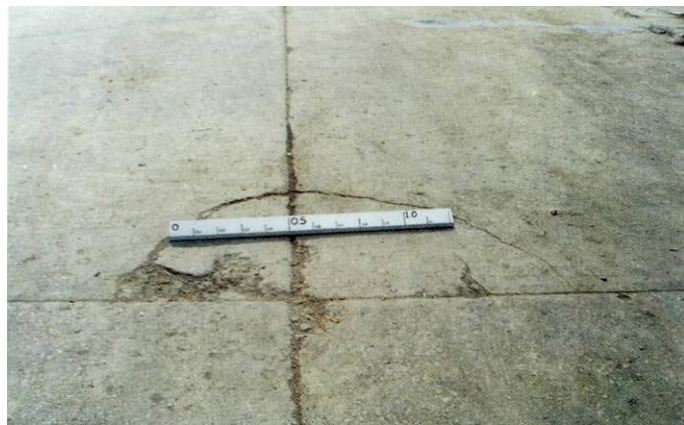
Crack linking a transverse joint to the slab edge or a longitudinal joint – Plates 3 & 4

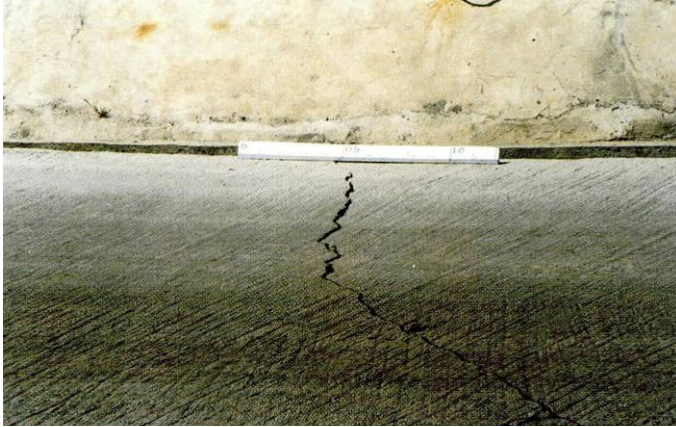
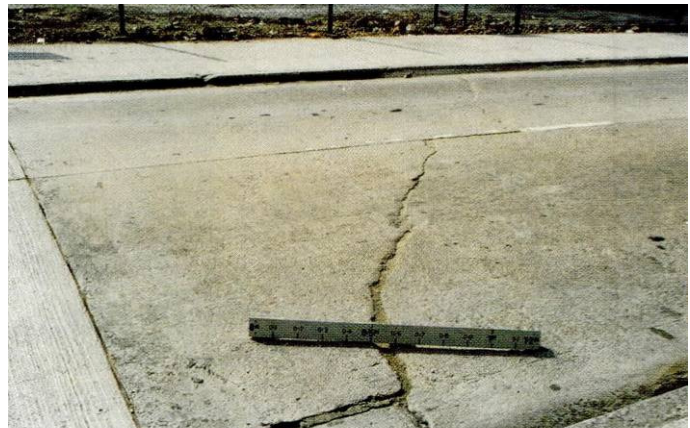
Multi-directional cracks in the slab which are neither generally transverse, nor longitudinal, nor across the corners of bays – Plates 5 & 6

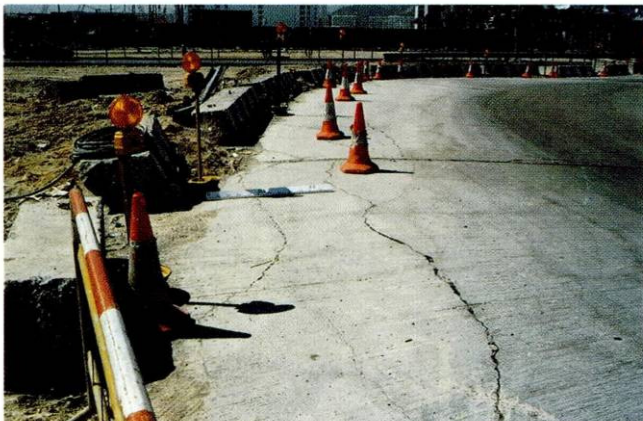
Unconnected crack running longitudinally along the pavement – Plates 7 & 8

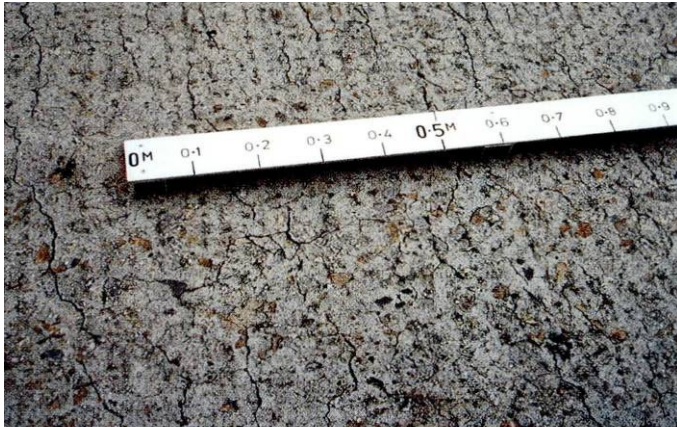
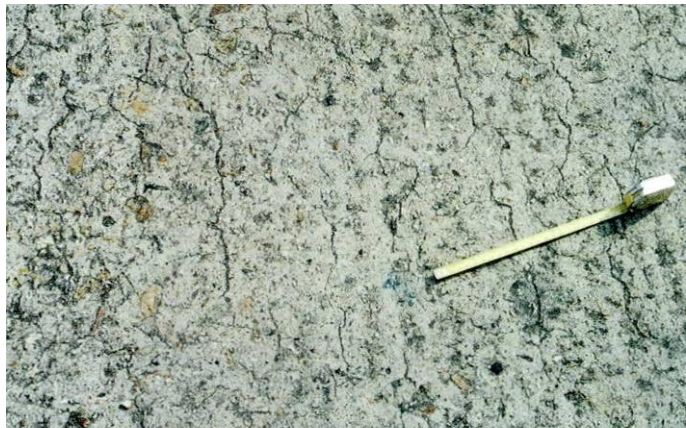
Short and oblique in direction and characteristically do not normally extend to the edges of the slab. Initially they are comparatively shallow in depth but as a result of subsequent heating and cooling, wetting and drying, it is likely that some at least will eventually extend across the full width and through the full depth of the slab – Plates 9 & 10

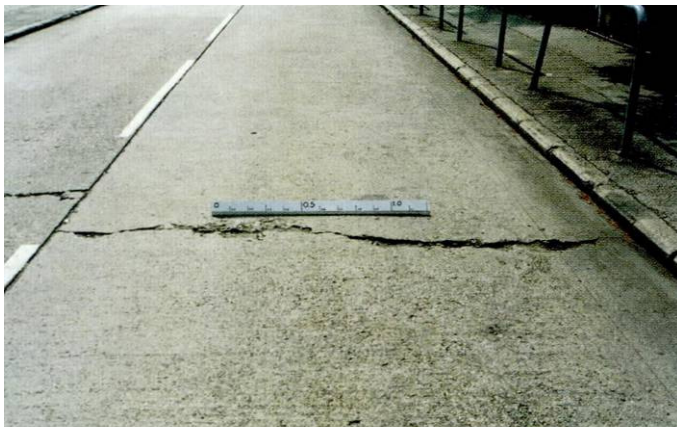
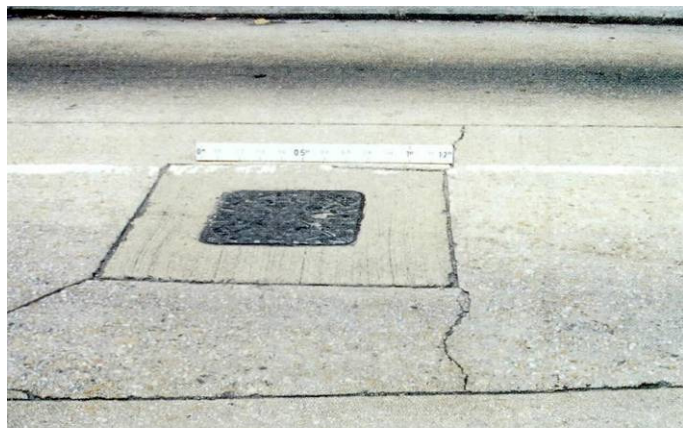
Crack or break running transversely across the pavement/slab – Plates 11 & 12

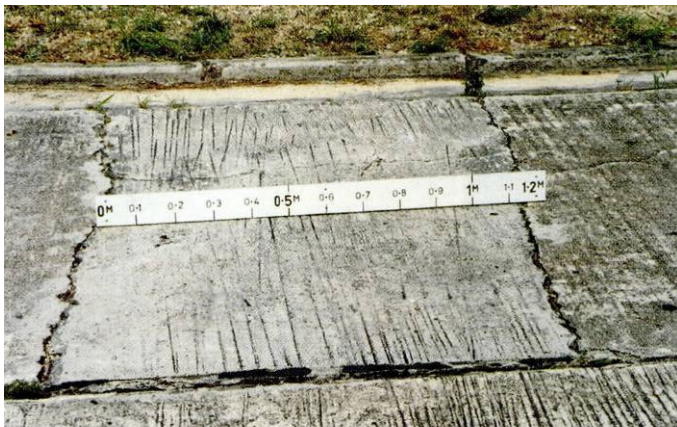
Plate 15

Vertical movement at joint (or crack) when vehicles pass over – Plate 15, sometimes the vertical movement cause water of slurry to be ejected up through the joints or cracks leading to loss of support which may be referred to as pumping – Plate 16

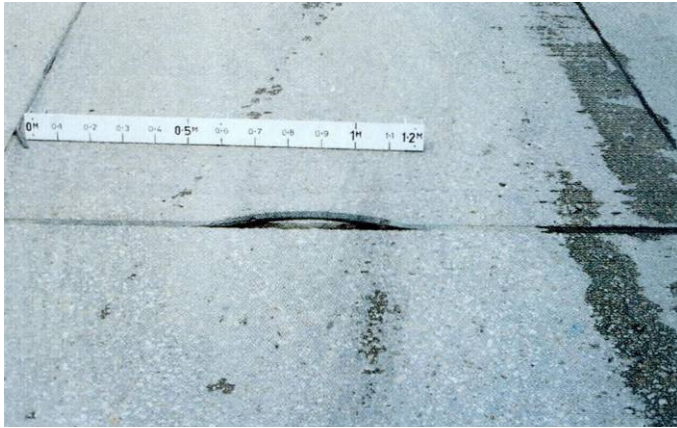
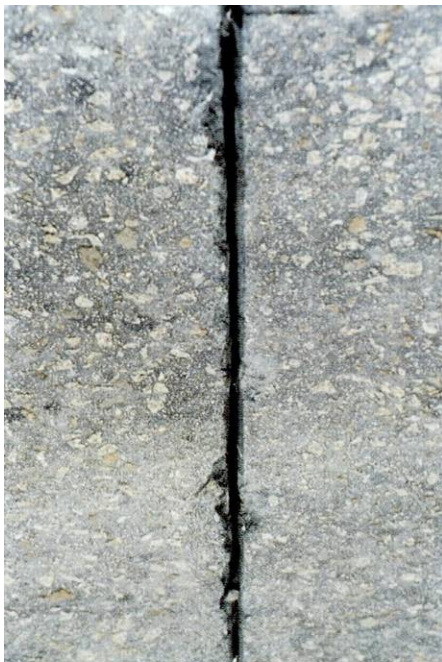
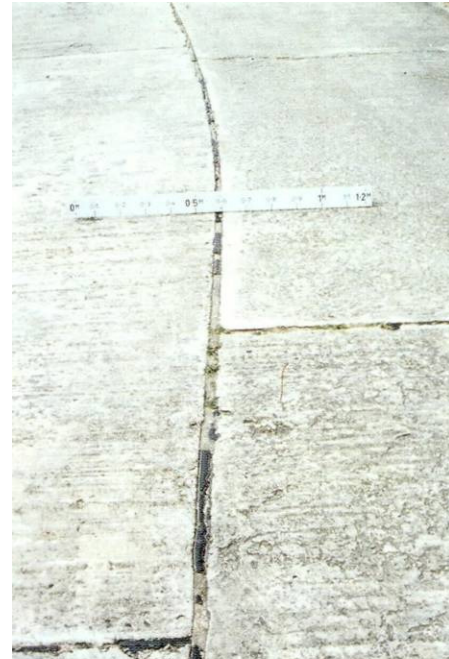
Loss and/or cracking of the seal resulting in foreign material in the joints. Extrusion of sealant leaving mould at joint – Plates 17 to 19

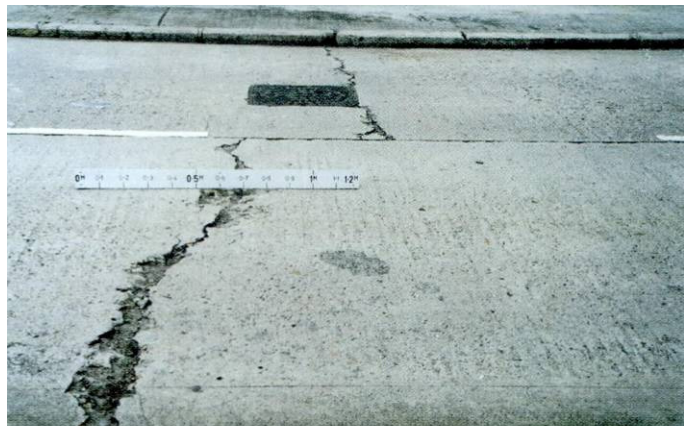
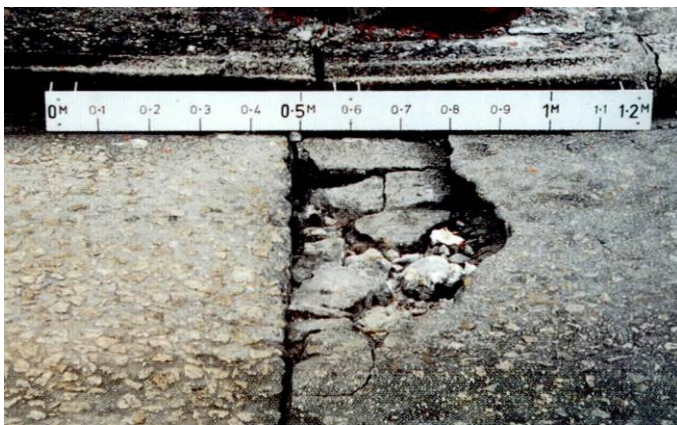
Break down or disintegration of slab surface at edges, joints, corners or cracks – Plates 20 & 21

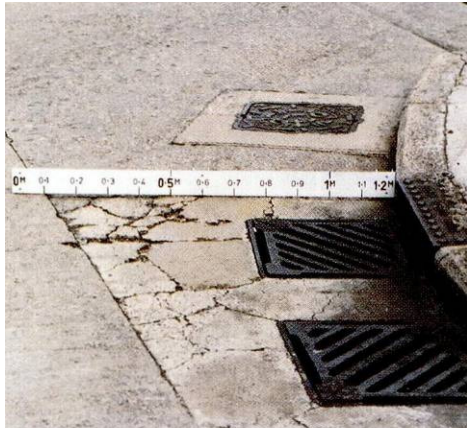
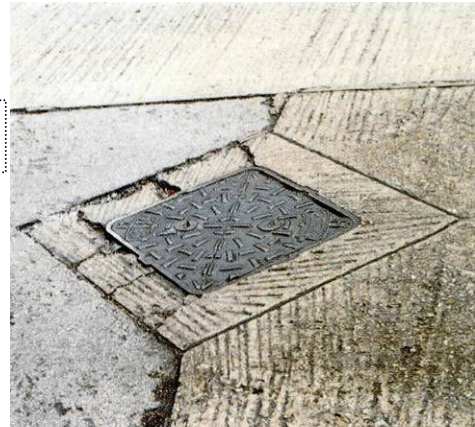
Cracks developed across the slab emanating from manhole and gully recesses – Plates 22 & 23

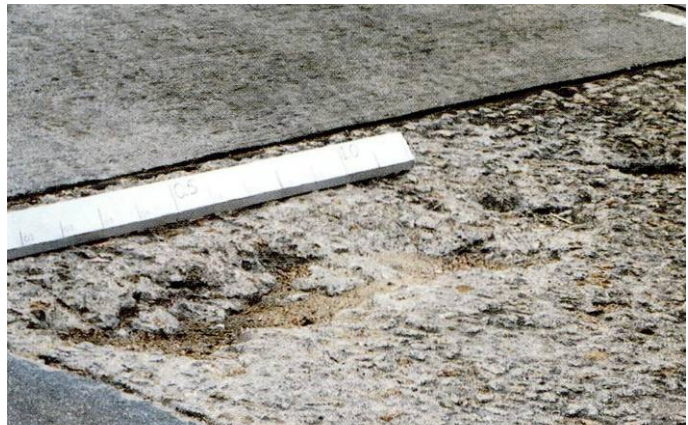
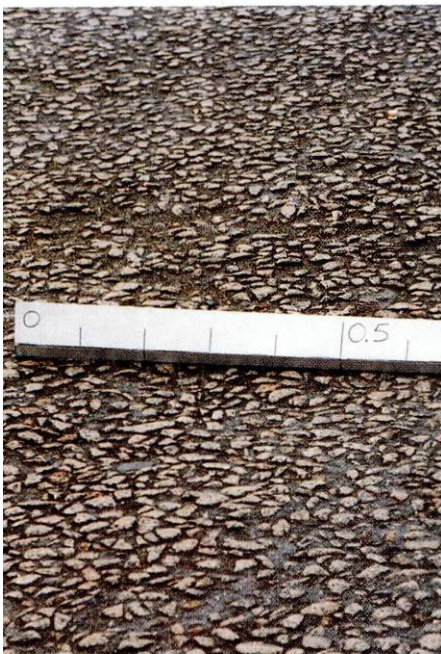
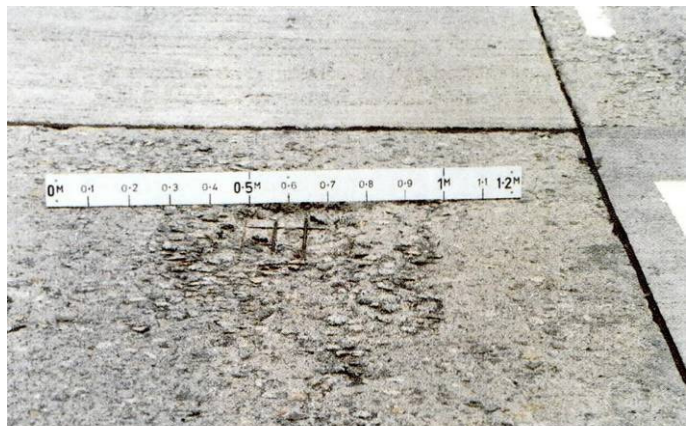
Progressive disintegration of surface; first loss of mortar, then loss of aggregates – Plates 24, 25 & 26 (synonym – scaling)

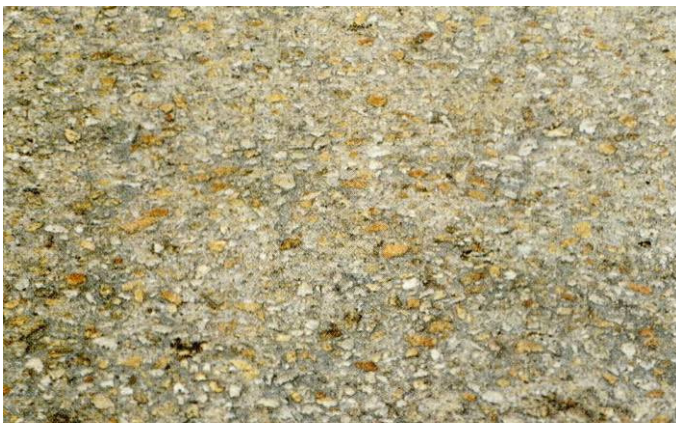
Inadequate skid resistance due to surface microtexture or macrotexture, rounded, smooth, polished or glassy appearance – Plate 27 (synonym – slippery surface)

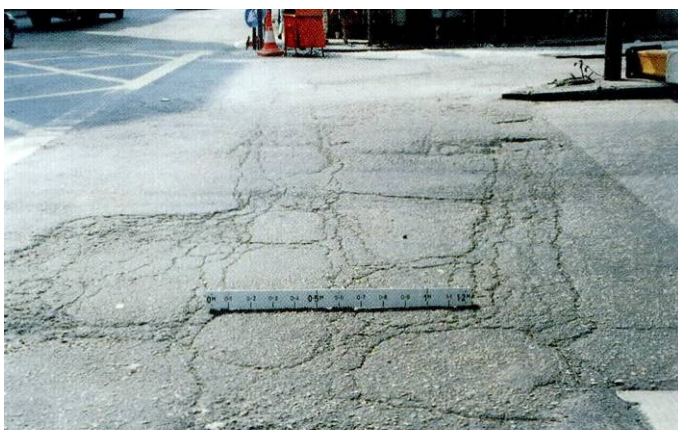
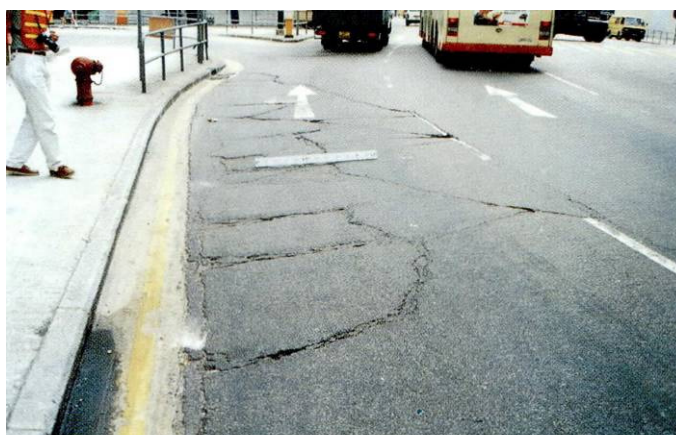
Interconnected cracks forming a series of large polygons. Cell sizes are usually greater than 200 mm and can exceed 3000 mm – Plates 28 & 29 (synonym – ladder cracks, map cracks)

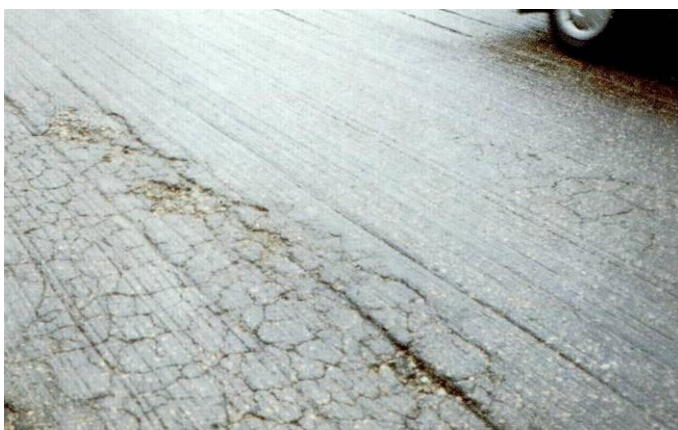
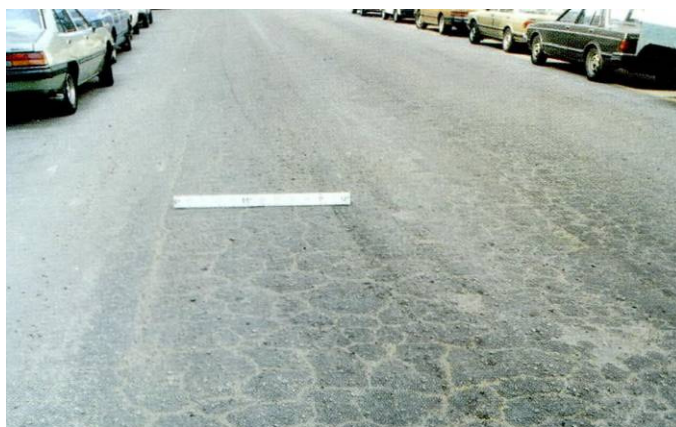
Interconnected or interlaced cracks forming a series of small polygons resembling a crocodile hide. Usually associated with wheelpaths and with resilient subgrade. Cell sizes are generally less than 150 mm across but may extend up to 300 mm – Plates 30 & 31 (synonym – alligator cracks, crazing)

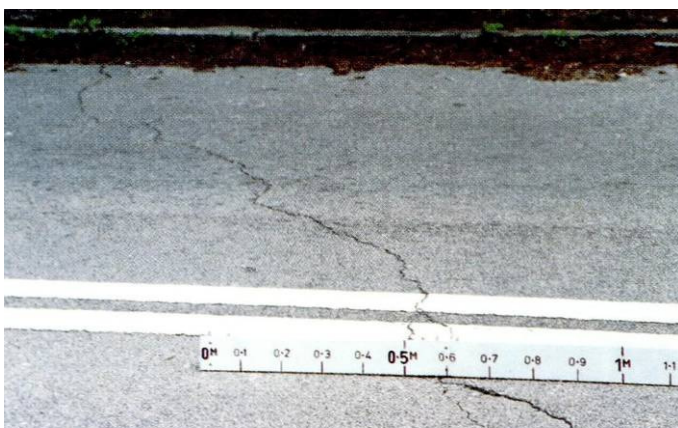
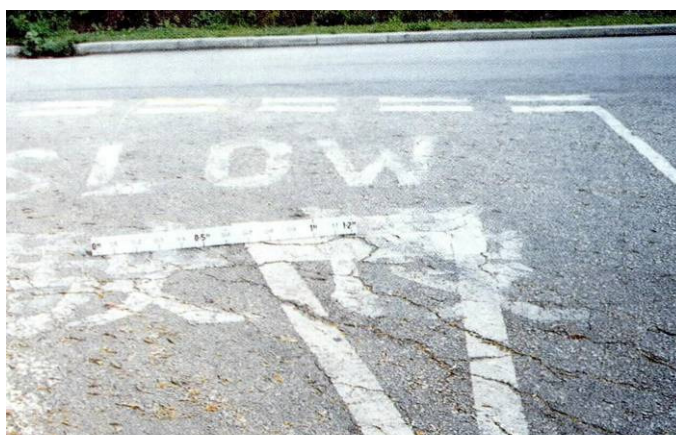
An unconnected crack which generally takes a diagonal line across a pavement – Plates 32 & 33

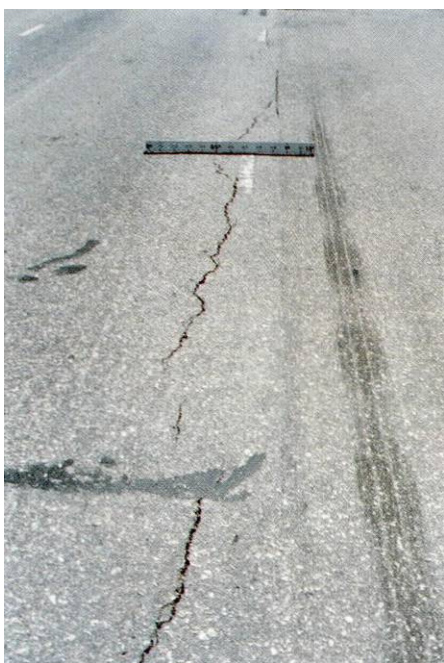
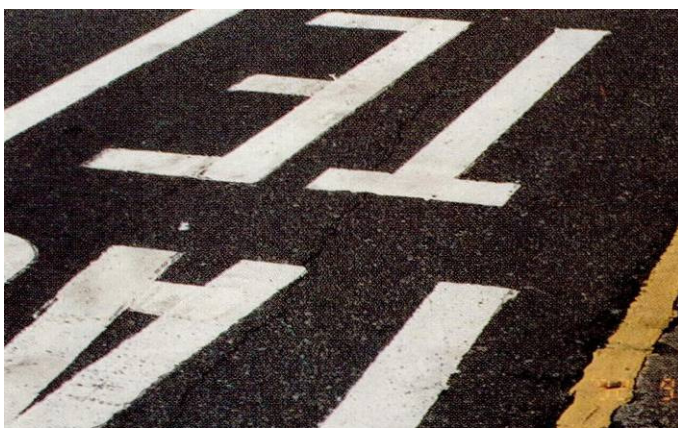
Crack running longitudinally along the pavement. Can occur singly or as series of almost parallel cracks. Some limited branching may occur – Plates 34, 35 & 36

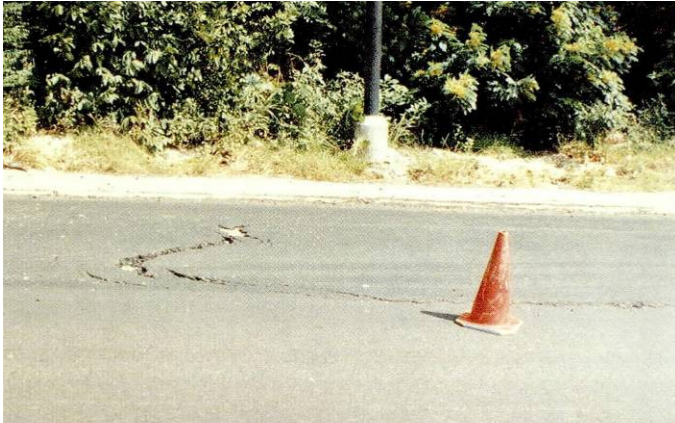
Plate 37

Half moon or crescent shaped crack in the direction of traffic, commonly associated with shoving – Plates 37 & 38 (synonym – shear crack, crescent crack)

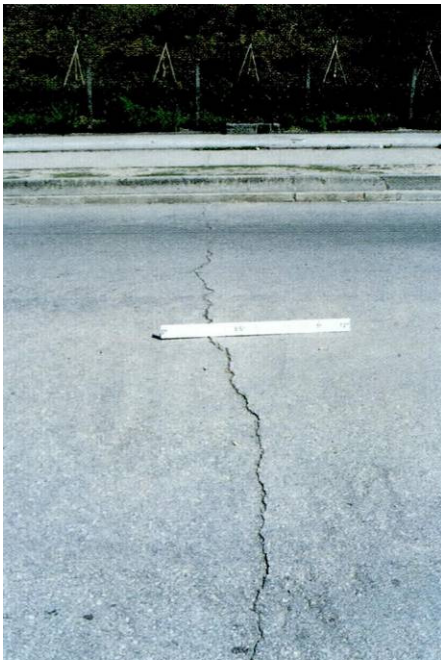
Transverse rupture across the pavement – Plates 39 & 40, for bituminous surfacing over bridge deck or concrete slabs. The crack reflect movement or pattern in the underlying pavement structure and is referred to as reflection crack – Plate 41

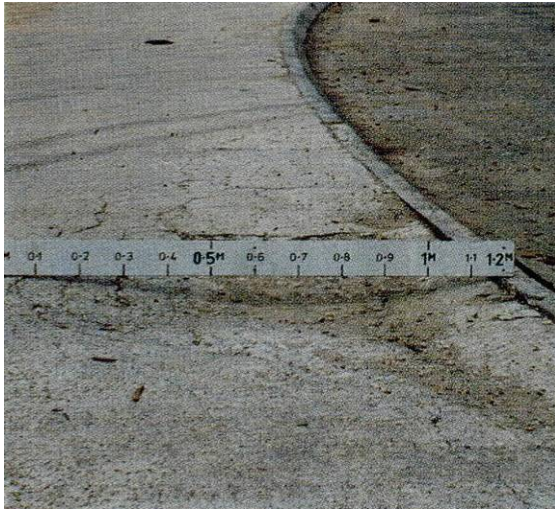
Interconnected or isolated cracks of any shape – Plate 79

- Insufficient slab thickness
- Settlement of sub-base or subgrade
- Vehicle damage

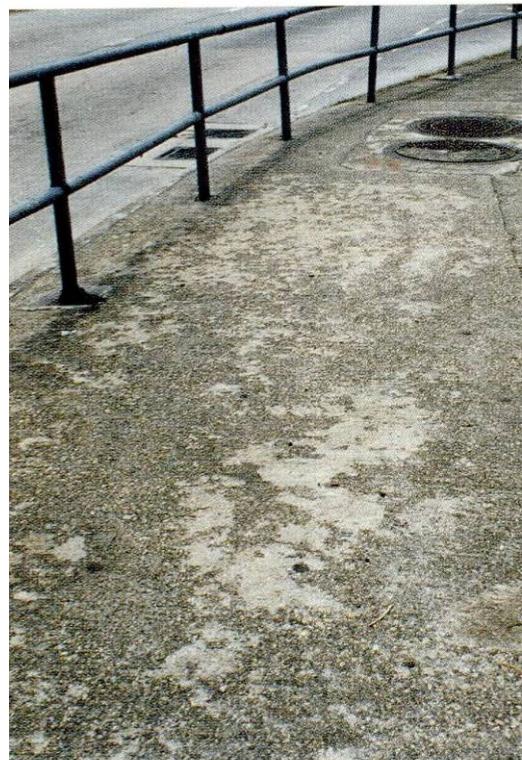
Localised area with elevations lower than the surrounding area – Plate 80

- Loss of sub-base support
- Settlement of service trenches
- Consolidation of isolated areas of soft or poorly compacted subgrade or embankment materials
- Vehicle damage

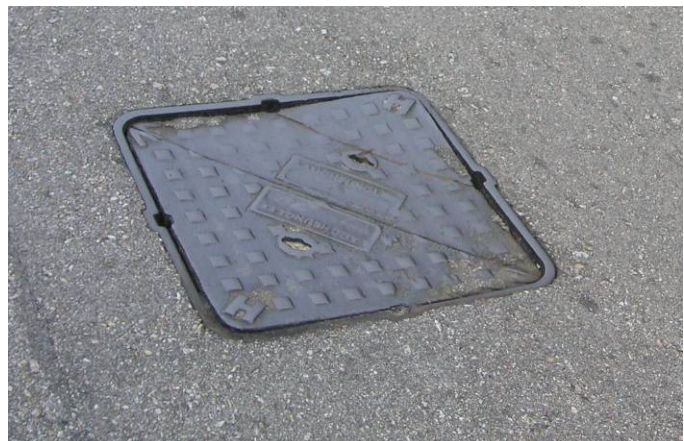
Plate 83

Cracking (plate 83), damage (plates 84 & 85), misplacing, loosening, sinking (plates 86 & 87) or missing (plates 88 & 89) of drainage / utility covers, gratings and frames
