12 CULTURAL HERITAGE IMPACT

In accordance with the EIA Study Brief, a Marine Archaeological Investigation (MAI) was commissioned to cover the seabed which will be impacted by the construction of Hong Kong Boundary Crossing Facilities (HKBCF). The aim of the MAI is to assess the impact of the HKBCF on marine archaeological resources and recommend any mitigation measures, if necessary.

The MAI covers the footprint of the HKBCF and associated installations plus a buffer zone of 100m to allow for the impact of working vessels during construction. The HKBCF layout and MAI study area are shown in the **Figure 12.1**.

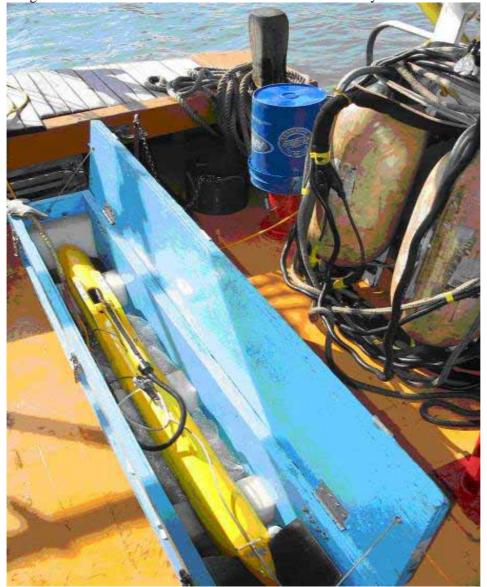
Image 1 The DF-100 used in the side scan sonar survey

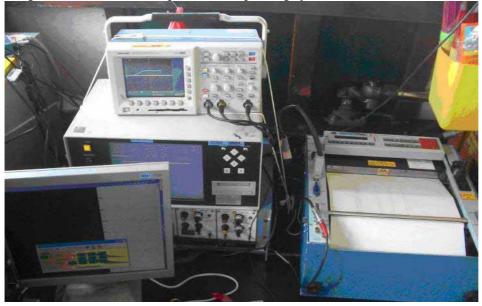
Image 2Seismic acquisition and printing system

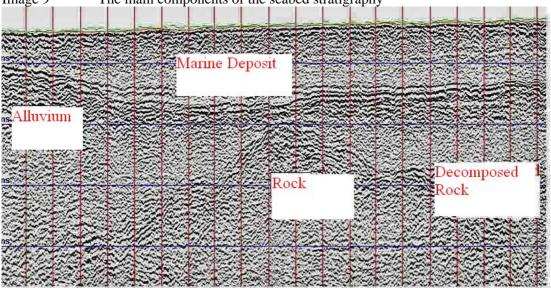
Image 9 The main components of the seabed stratigraphy

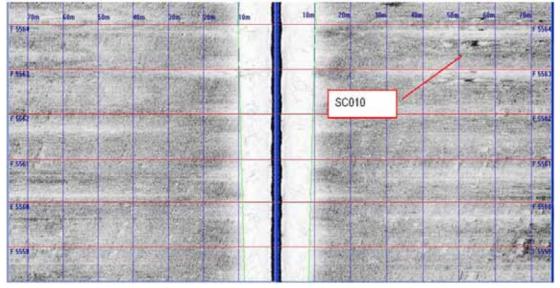
Image 13 Side scan sonar contact SC010

Careful examination of the side scan sonar records does not provide evidence for intact shipwrecks. It is more likely that each of the targets is an isolated object or a shipwreck which has been broken up by previous disturbance, such as trawling.

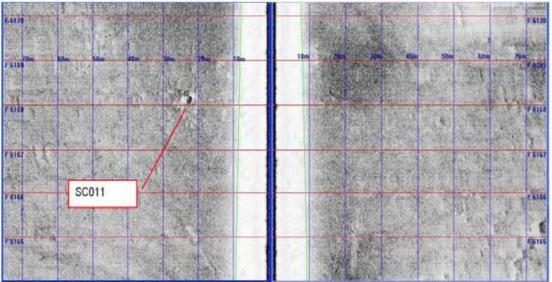
Image 14Side scan sonar contact SC011

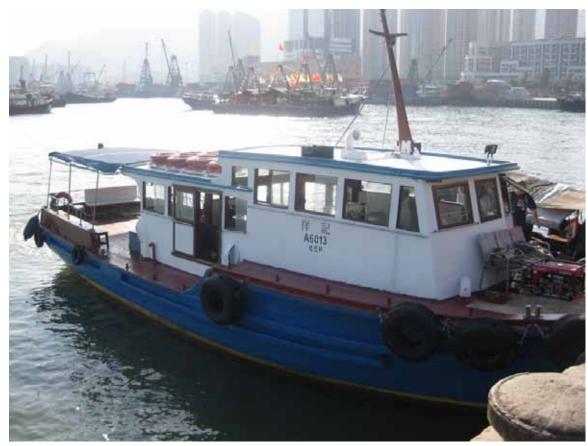
Boat used for Diver Survey

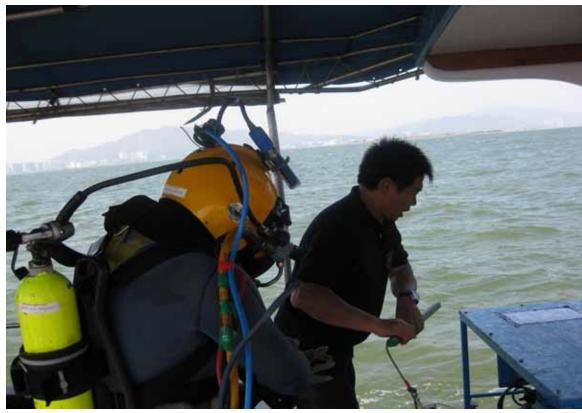
Diver wearing helmet mounted video camera

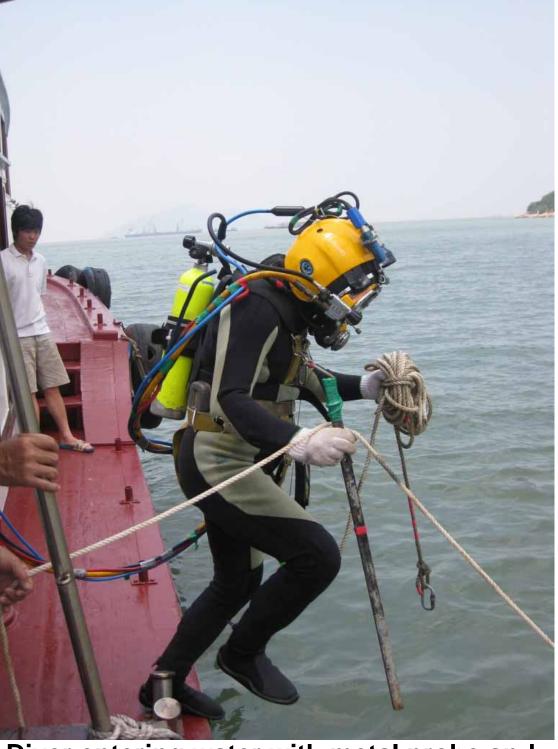
Diver entering water with metal probe and rope for circular search

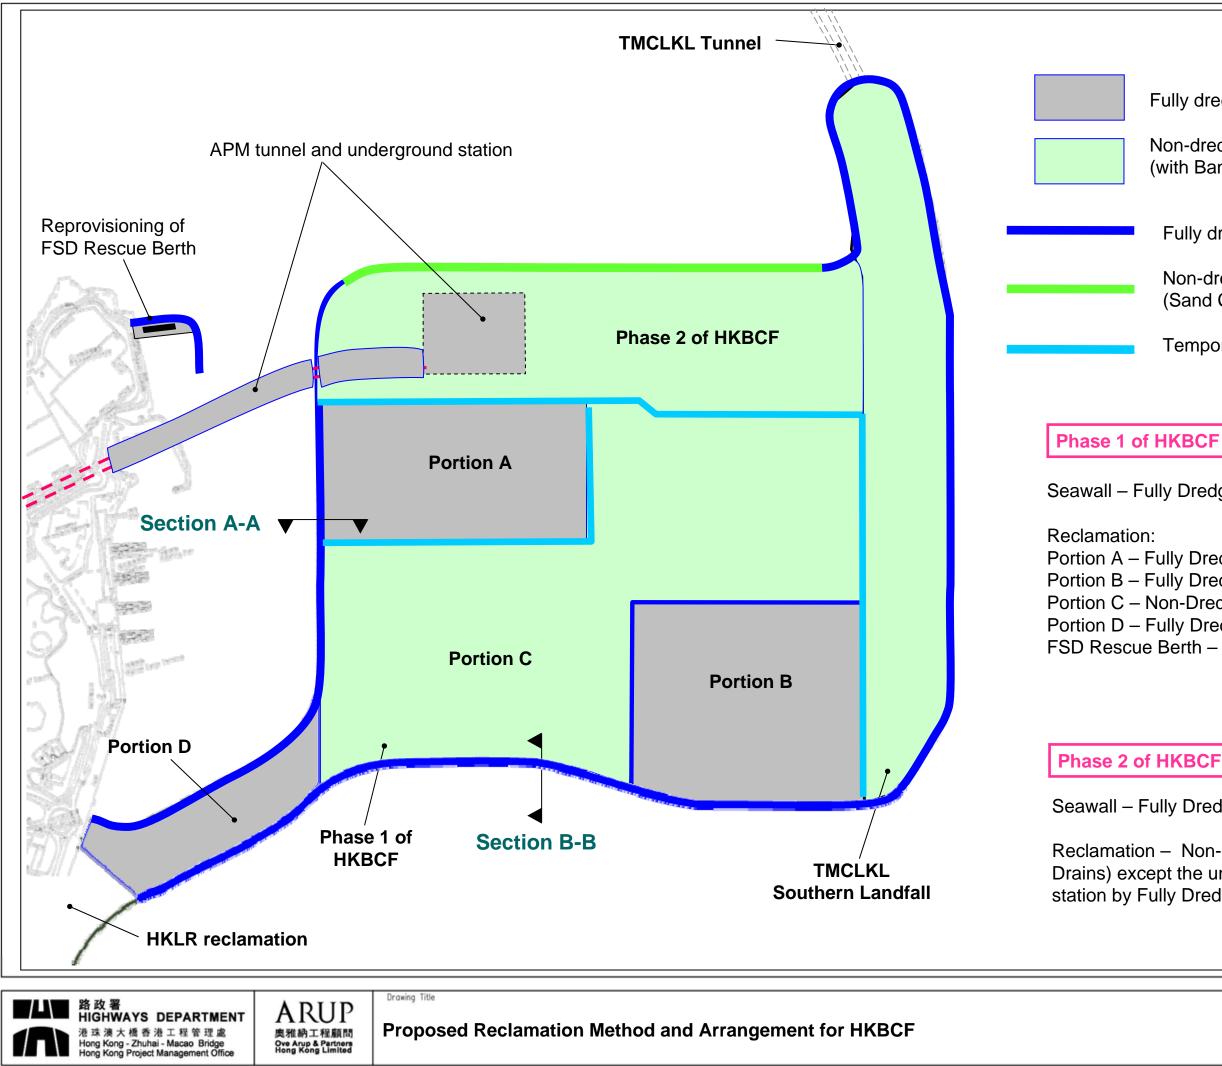
Fully dredged Non-dredged (with Band Drains) Fully dredged seawall Non-dredged seawall (Sand Compaction Pile - SCP) Temporary seawall Seawall - Fully Dredged Portion A – Fully Dredged Portion B – Fully Dredged Portion C – Non-Dredged (with band drains) Portion D – Fully Dredged FSD Rescue Berth – Fully Dredged

Reclamation – Non-dredged (with Band Drains) except the underground APM station by Fully Dredged.

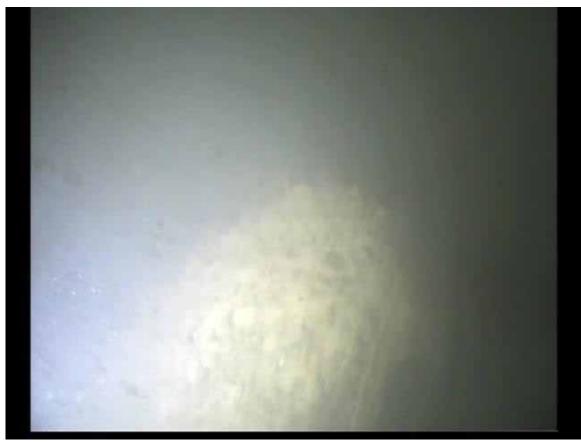
Photograph of sonar contact SC010

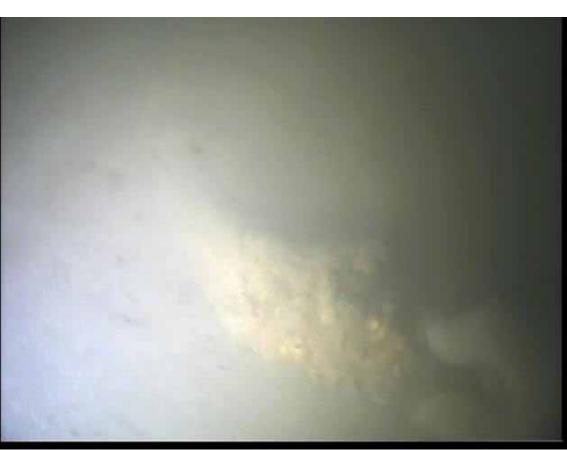
Photograph of sonar contact SC011
